**Analysis of Service-Retrieved TBC-Coated Industrial Gas Turbine  
Components**

**A Dissertation Submitted for  
MPhil Examination  
Imperial College London  
June 2010**

## Abstract

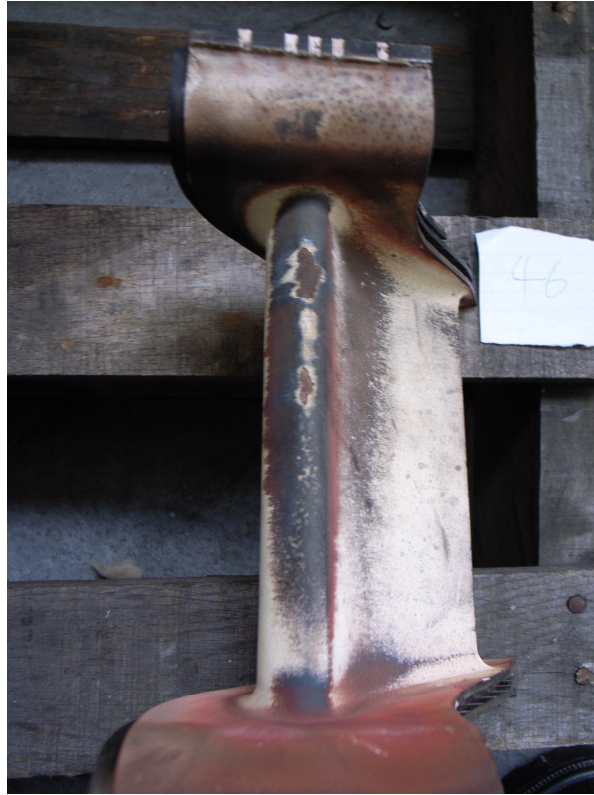
Pressure side images of Vanes A, B, and C are shown in Figure 20. The TBC surface discoloration as observed by visual inspection varies dramatically between the vanes: Vane A had most of its surface covered (approx 75 % surface area) by the deposit, Vane B 50% and Vane C had the least (approx 35 %). The discoloured areas reveal dark / light brown, red and black deposits on all three vanes. Dark / light brown deposits tend to cover most of the area on the pressure side. Red deposits can only be seen near the pressure side leading edge. Lastly, black deposits are observed on both the pressure side leading edge and trailing edge. By looking vertically, fewer deposits appear to be accumulated near the platform side. Vane C, which reveals the highest ratio of black deposit, has TBC coating spallation observed at its pressure side leading edge, as shown in Figure 25.

Figure 25 Spallation of Vane C on the pressure side leading edge

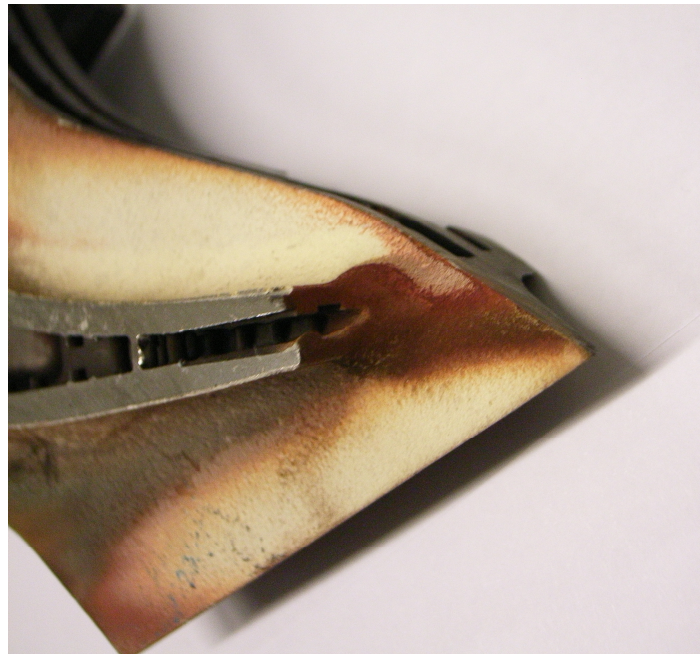
The vane platforms were also examined and have a notable discoloration pattern. One of the most interesting observations is that the distribution of red deposits tends to align with the path of cooling air from the trailing edge as shown in Figure 26. Unlike the hot gas exits from the combustor, this internal cooling air contains much higher oxygen content (close to atmospheric  $PO_2$ ).

Figure 26 Red deposit near the cooling duct

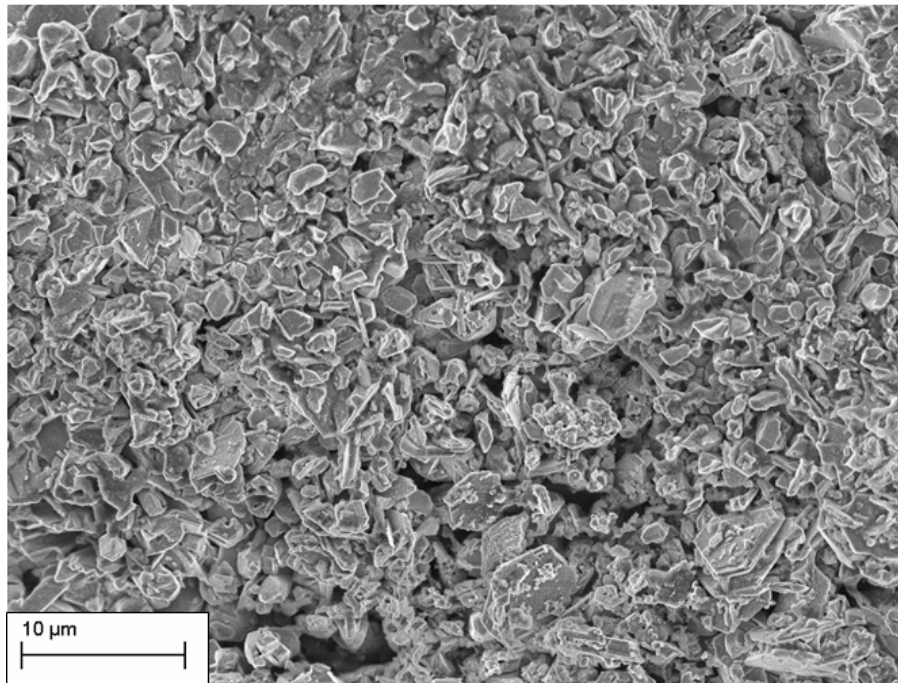
Surface SEM imaging on the deposit has revealed several surface morphologies. The most commonly observed surface structures were granular and flagstone-like plates (Figure 27 and Figure 28). The size of the granular particles was relatively uniform, ranging from 2 to 4  $\mu\text{m}$ . The flagstone-like plates, on the other hand, had much more variation in size with typical plate sizes ranging from 3 to 10  $\mu\text{m}$ . For the larger plates, a horizontal ridged surface was also observed. Consolidated regions (Figure 29) and needle-like structures (Figure 30) were also observed; however, these microstructural features occupied only a minor fraction of the total surface area analyzed.

In general, regions with brighter surface deposits (light brown, bright red) tend to have uniform granular microstructures. Regions with darker surface deposits (dark brown, black) reveal flagstone-like plates. The black deposits, in particular, have almost the complete surface dominated by large plates, whereas dark brown deposits have mixtures of granular and plate surfaces.

Figure 27 Granular structures on the commonly observed on the lighter colour deposit surface on the pressure side; SE image

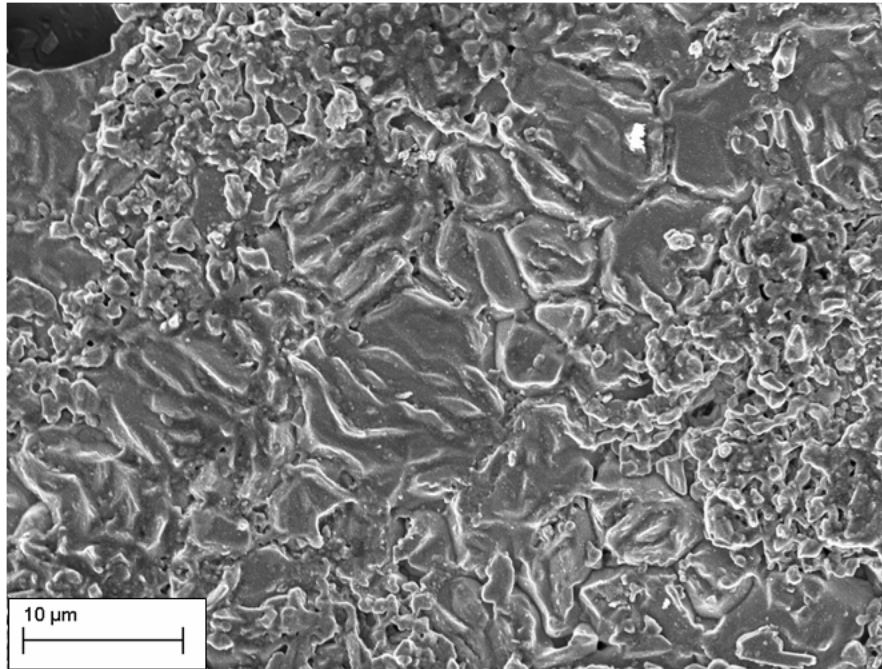
Figure 28 Flagstone-like plates commonly observed on darker deposit surface SE image

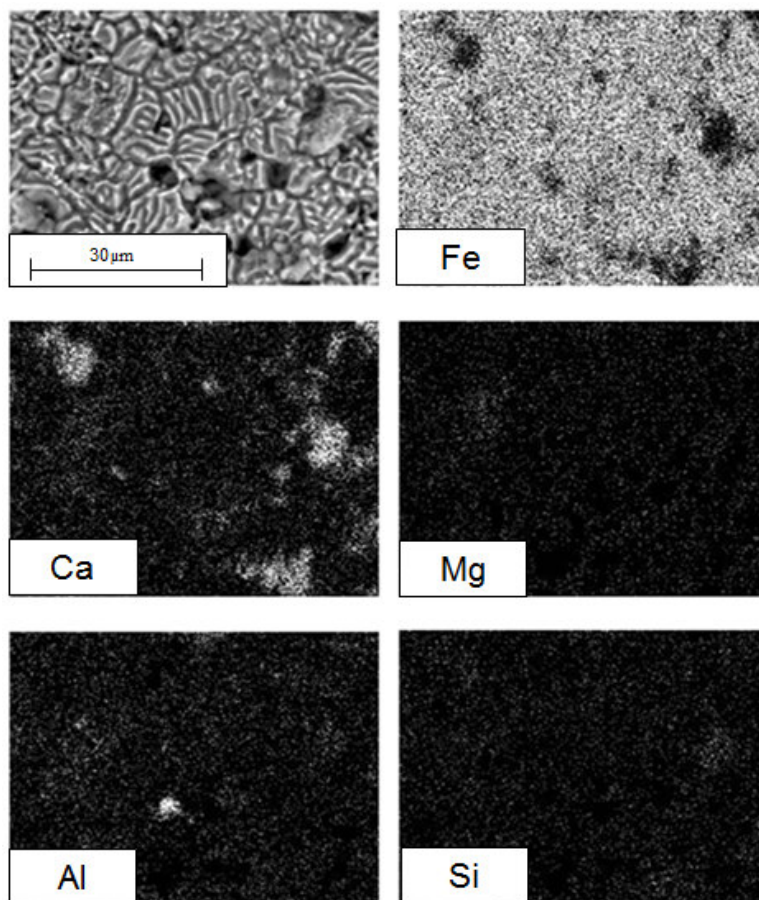
aluminium contents observed from Figure 32 are corresponding to the gaps and openings between the flagstone-like plates.

Figure 32 EDS Mapping on Flagstone plate surface reveals mostly iron on the surface, the top left presents an SE image of the mapped area

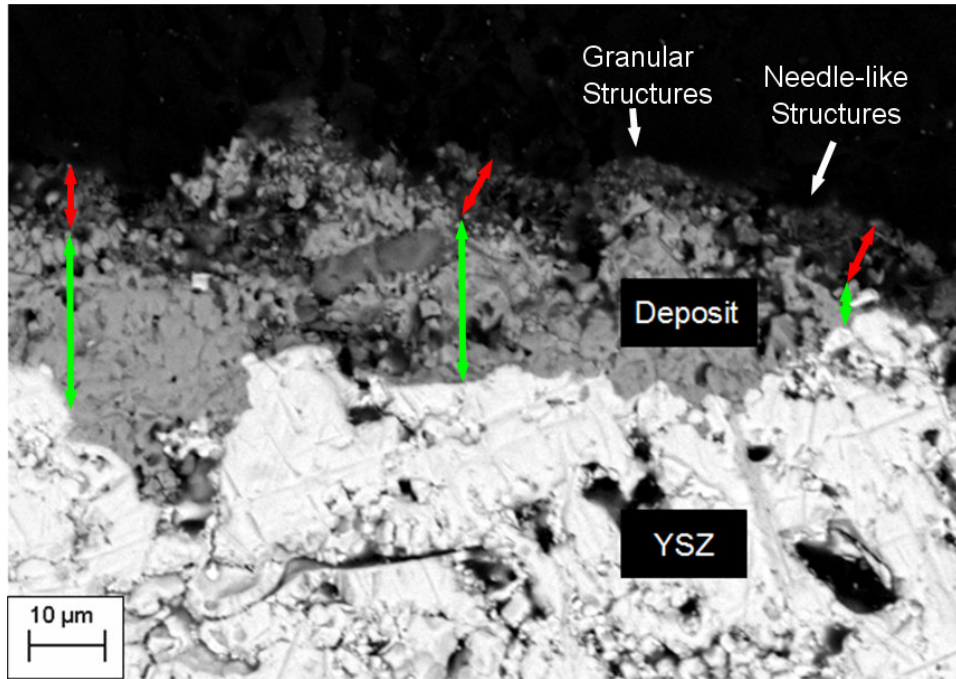
Cross-sectional analyses have been conducted on the various deposits. Figure 33 and Figure 34 show areas with light brown and red deposits, respectively. A large number of voids (the black contrast within the deposit layer) were observed within these deposits. The back scattered electron mode (BSE) images also revealed multiple phases within the deposit layer. A dense, darkly imaging layer exists at the most outer layer of the deposit (indicated by the red arrows), follow by another layer of bulk lighter contrast phase (indicated by green arrows). This outer layer is not uniform in thickness and contains granular or needle-like structures. This is consistent with observations from the surface using SE imaging that granular structure dominates the surfaces of lighter colour deposits (light brown and red). These cross-sectional images revealed that the granular layer is only a thin layer on the surface while a compact layer lies underneath. The granular layer

shows lower BSE - contrast, indicating the presence of low atomic number elements. At this stage, the structure of the inner layer is still unknown as the surface SEM could only reveal the outer layer, but the layer will contain elements of higher atomic number than the outermost layer.

Figure 33 Cross-sectional SEM of light brown deposit; BSE image

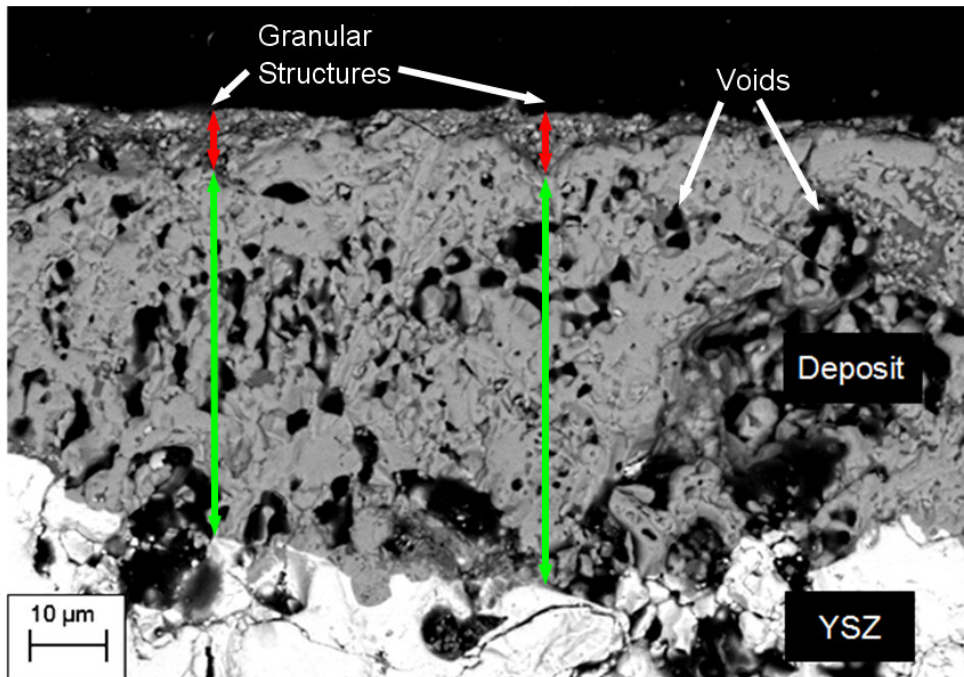
Figure 34 Cross-sectional SEM of red deposit; BSE image

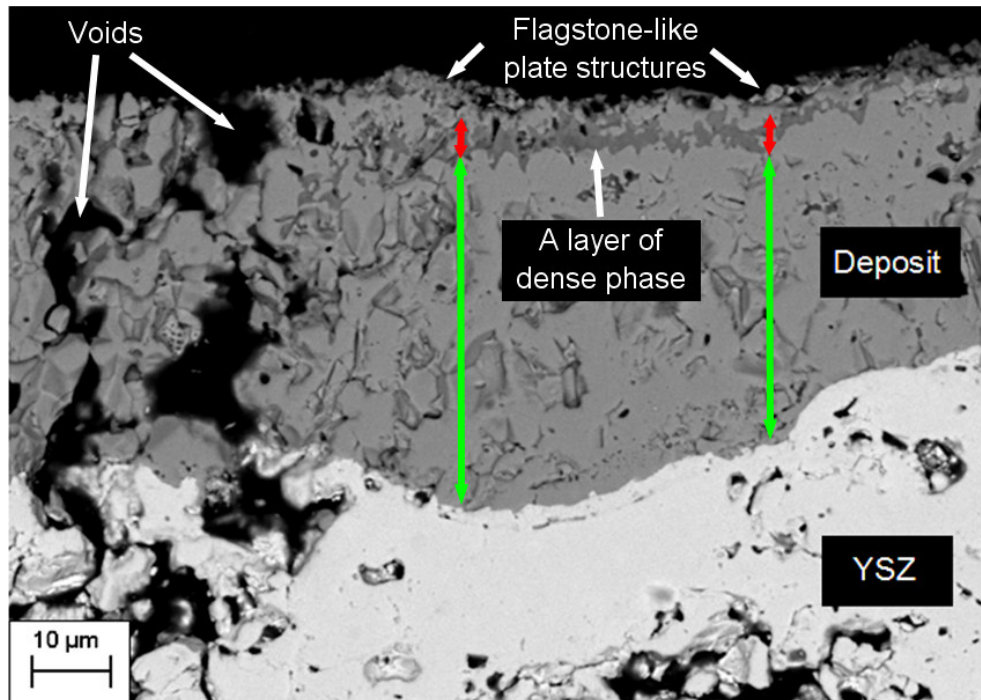
Figure 35 and Figure 36 are cross-section SEM images of the black and dark brown deposits (darker colours) from Vane B. These darker colour deposits are more consolidated with lower fractions of porosity as well as thicker than the lighter colour deposits (more accumulation of deposits). Most of the observed porosities are larger than that observed in the red and light brown deposits. This suggests a sintering effect may have taken place in the darker deposits during the CCGT operation. It is suspected that small porosities were initially present during the accumulation of the deposit, and as the accumulation continues, these small porosities agglomerate into larger voids. Multiple layers in the deposit are also identified from the images below; a dense layer present at or near the surface as indicated in the Figures with a lighter contrast layer occupying the rest of the deposit thickness. From these cross-sectional SEM images of the deposit, it can be seen that the high density phase often exists in a form of narrow layer parallel to the surface. Recalling from surface SEM analysis on these sites, the surfaces of these deposits are mostly covered by flag-stone like plate structures with a minor fraction of granular structure below the plate structures. EDS mapping of the surface (Figure 32) reveals calcium and aluminium signals from the regions beneath the plates.

Figure 35 Cross-sectional SEM of black deposit revealing a dense layer near the surface: BSE image

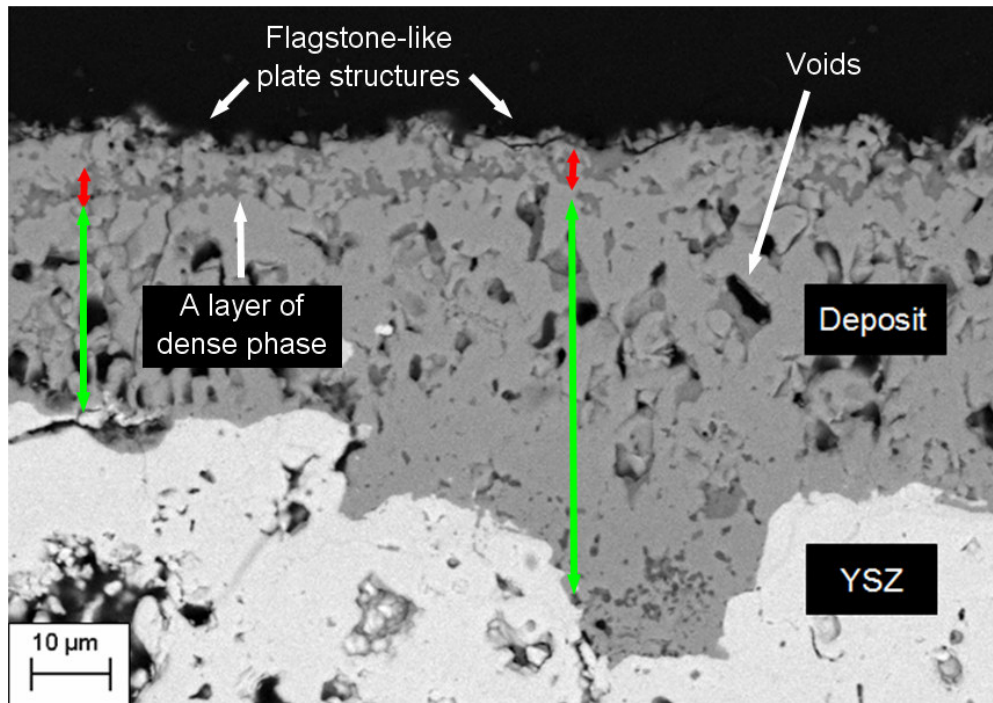
Figure 36 Cross-sectional SEM of dark brown deposit revealing a dense layer near the surface: BSE image

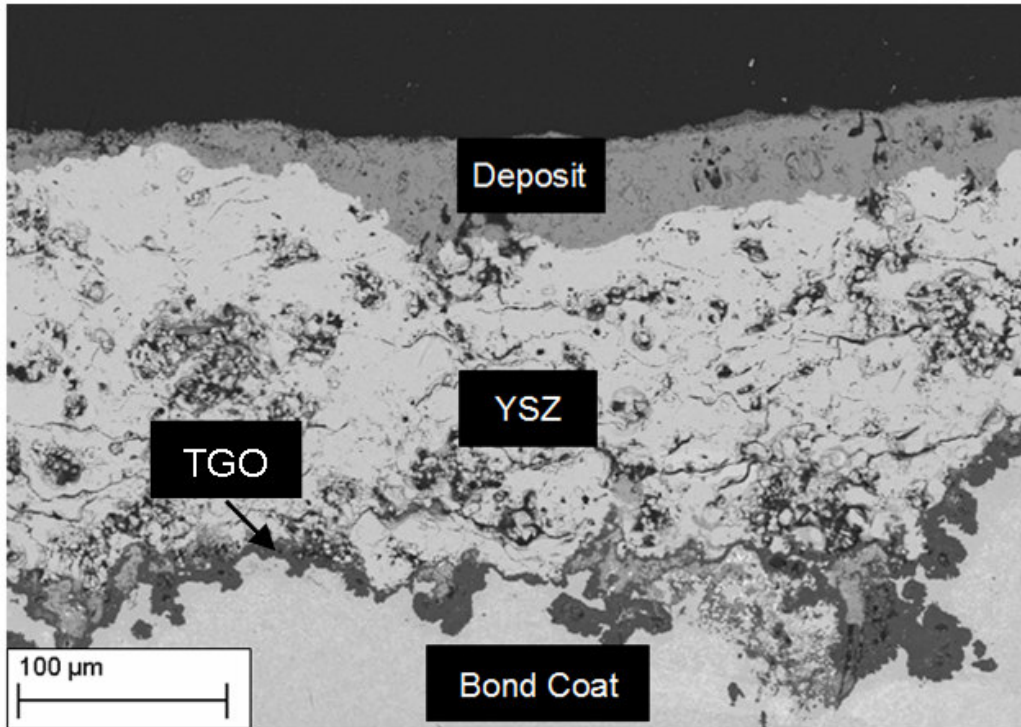
Figure 39 Cross-section SEM image of black deposit, revealing a thick and irregular TGO layer in between the YSZ and bond coat

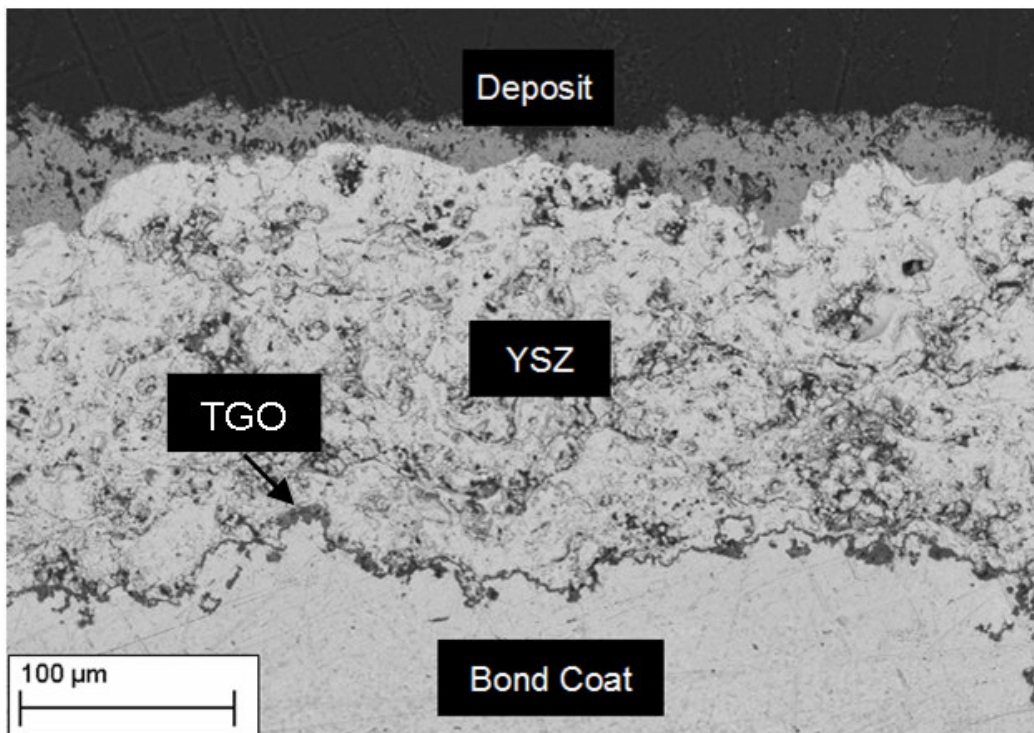
Figure 40 Cross-section SEM image of light brown deposit, revealing a thin and relatively uniform TGO layer in between the YSZ and bond coat

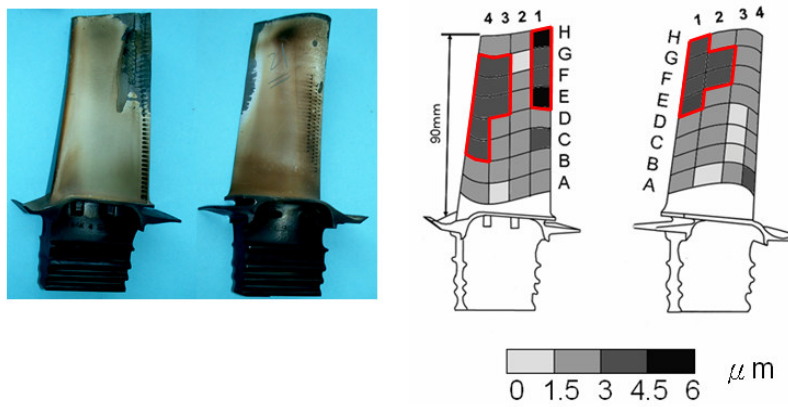
Figure 57 Comparison of failed blade #1 with the TGO plot of blade #2

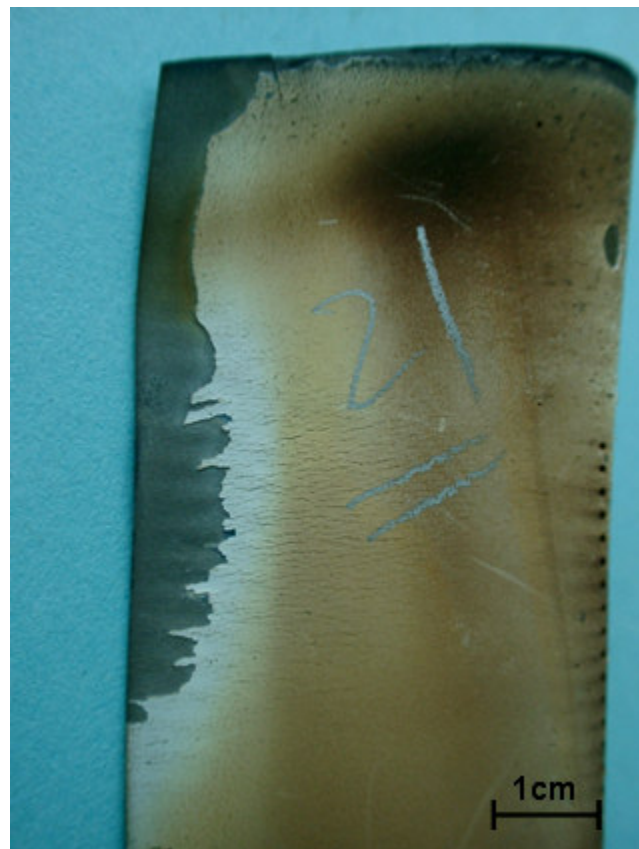
Figure 58 Blade #1 white surface observed right next to TBC failure site

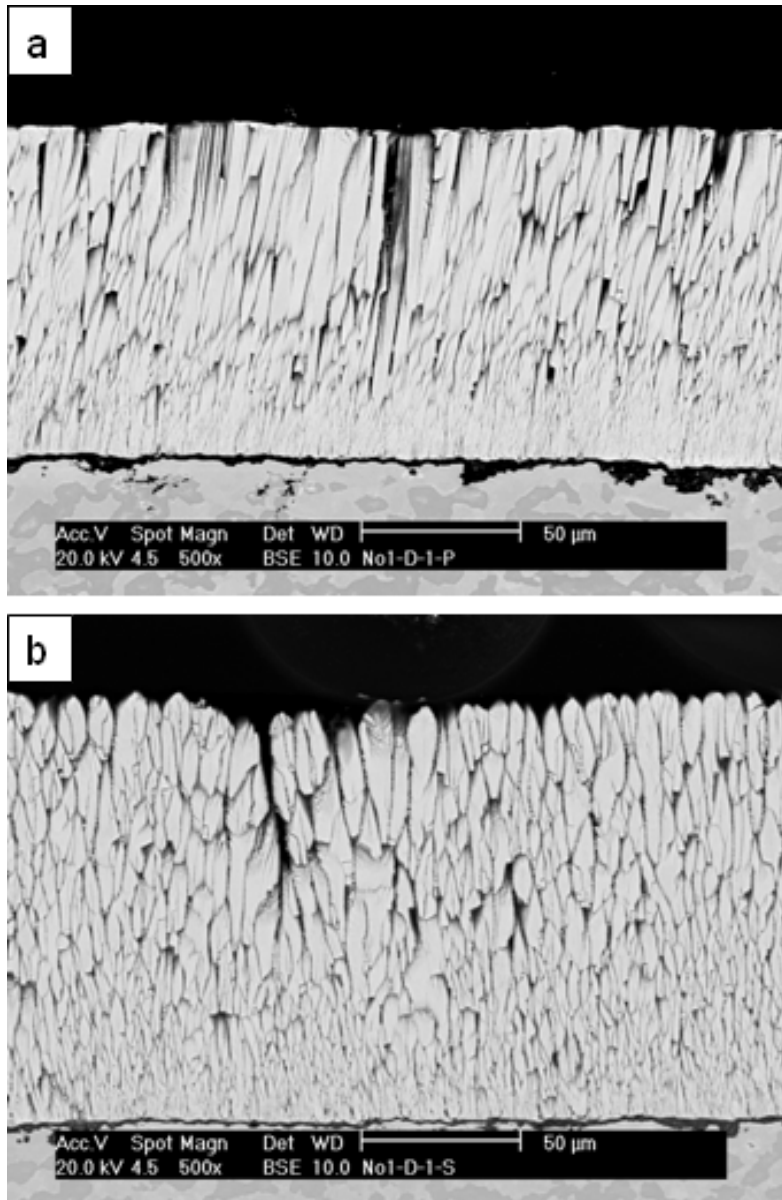
Figure 59 SEM image showing the a) Type I erosion eroded pressure side (flat smooth surface), and b) a non-eroded suction side of a sectioned blade piece of blade #2

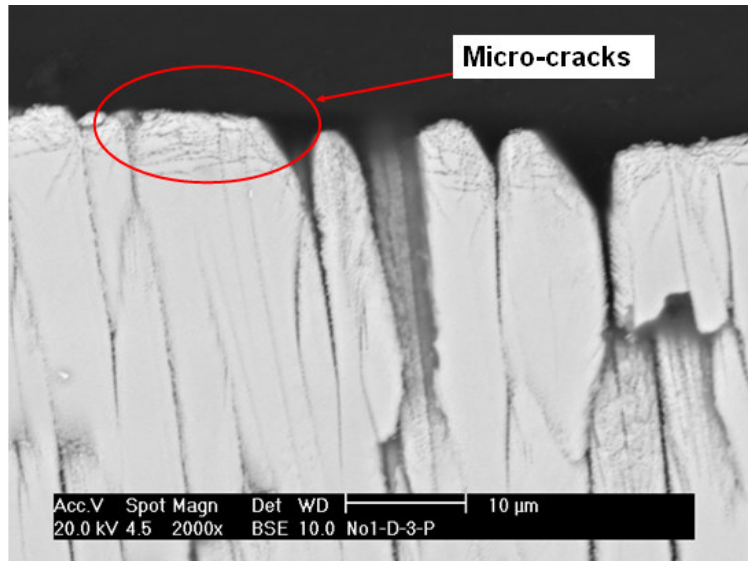
Figure 60 Micro-cracks near the tip of the YSZ on the pressure side of blade #2

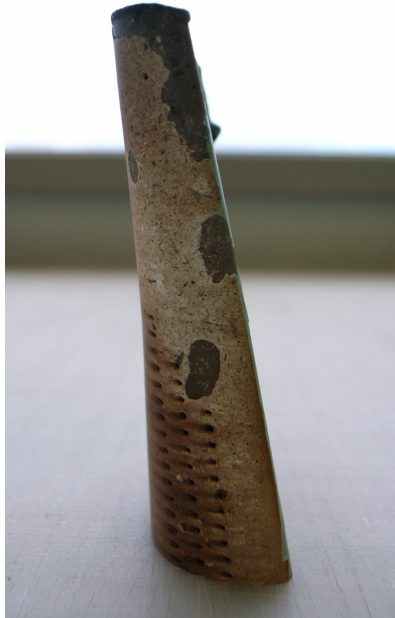
Figure 61 Spallation of TBCs on the suction side leading edge of blade #1

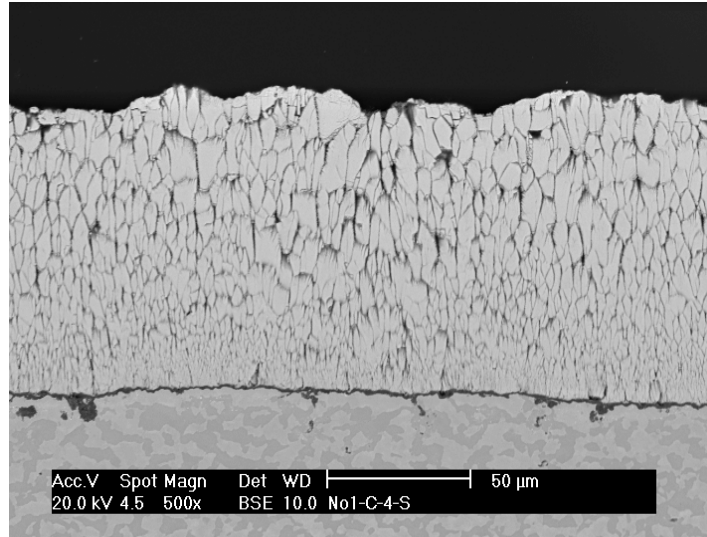
Figure 62 SEM image of Type II erosion near the suction side leading edge of blade #2

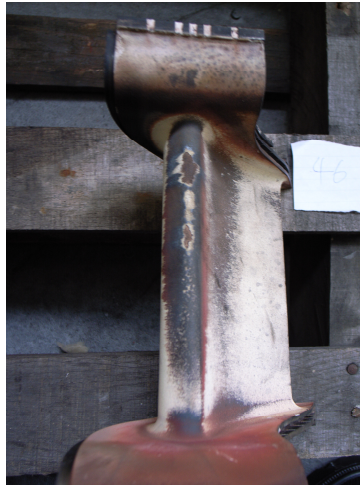
Figure 3 Spallation of Vane C on the pressure side leading edge

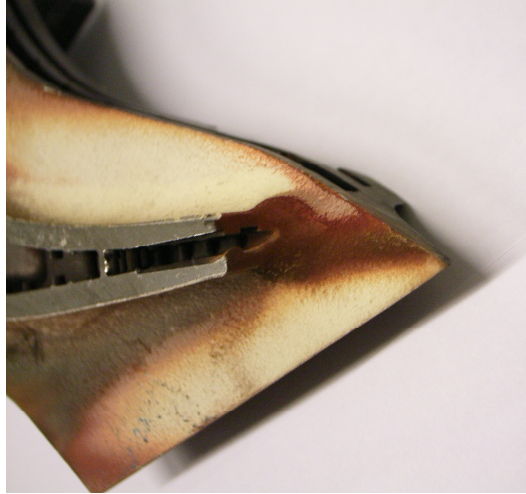
Figure 4 Red deposit near the cooling duct
