In-operando X-ray tomography study of lithiation induced delamination of Si based anodes for lithium-ion batteries

Abstract

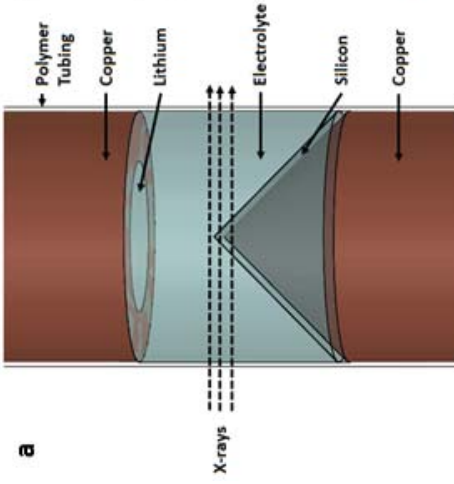
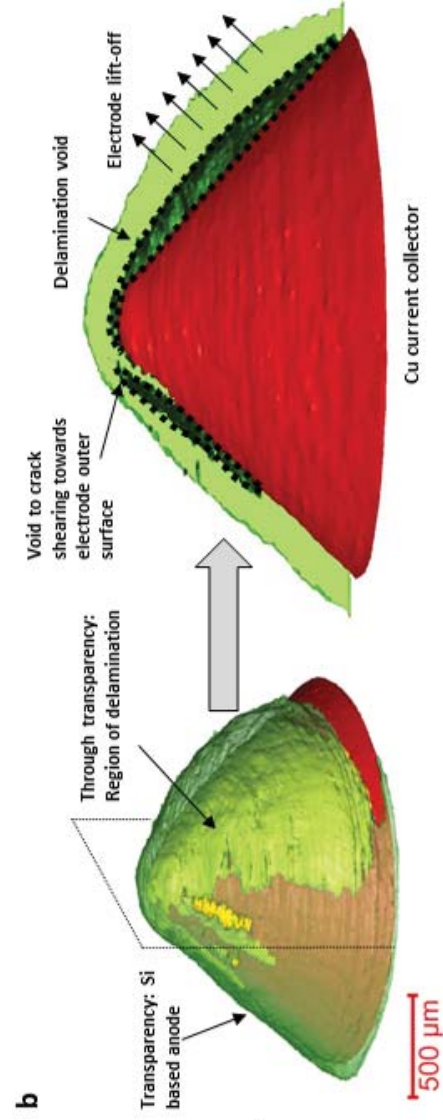
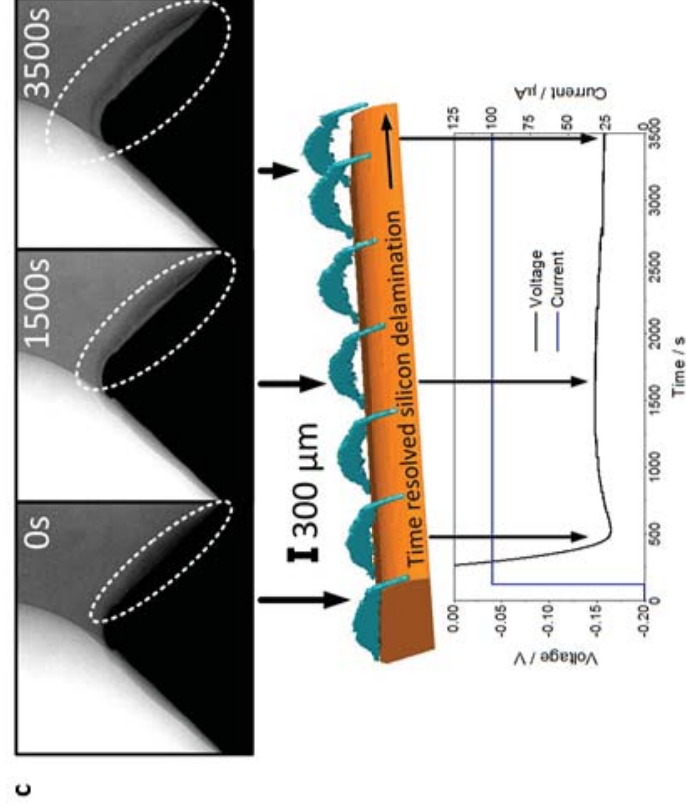
205 **Figure 1.** a) Si based anode tomography cell construction and X-ray direction, b) 3D reconstruction after lithiation with
206 delamination and, c) radiography during lithiation and delamination with voltage response.

52 A customised Si-Li half-cell was assembled in an argon filled glove box (Fig.1a). A lithium
53 metal anode and a silicon-carbon composite cathode were used. The copper current collector
54 rod was machined into a conical tip on the silicon side for X-ray imaging purposes. The final
55 cathode composition was 70 wt.% carbon-coated Si, 20 wt.% Shawinigan Black Carbon
56 (Chevron Chemicals), and 10 wt.% sodium carboxymethyl cellulose (Sigma-Aldrich). The
57 carbon-coated Si power was prepared via pyrolysis of 60 wt.% Si 30nm nanoparticles
58 (Umicore), 10 wt.% 50nm MWCNT (Skyspring Nanomaterials) and 30 wt.% of sugar(10). The
59 current collector was dipcoated into Si/C slurry and vacuum dried in a furnace. Ionic liquid
60 made from 1M LiPF₆ EC:DEC 1:1 v/v and 2 wt.% of VC electrolyte (Solvionic) was the
61 electrolyte. The active materials were enclosed by a Kapton® polyimide tube and sealed
62 air-tight using Torr seal® epoxy (Goodfellow). The Si based anode (0.1-0.2mg) provides an

64
65 The electrochemical cell was mounted in an X-ray Microtomography (XMT) system (Phoenix
66 v|tome|x, GE, USA) for direct imaging/tomography operated at 70 kV. Electrical wires were
67 attached to the cell to lithiate the silicon anode and current control was maintained through an
68 Ivium VERTEX (Ivium, Eindhoven, Netherlands) potentiostat. A galvanostatic charge current
69 of 100 μ A was applied to the cell for 1 hour whilst monitoring voltage and simultaneously
70 imaging the battery anode using X-rays (Fig.1a). After 1 hour the electrode was partially

101 The results show a clear difference between two regions of the silicon electrode. The
102 electrode region in contact with an argon bubble (white in Fig.1c [and supplementary material](#))
103 showed neither lithiation nor delamination, whereas the region in contact with the electrolyte
104 upon lithiation lifted off and delaminated in a concave 'bow shape' away from the current
105 collector. The inert bubble was present from battery manufacture. However, from these
106 results it is evident that lithiation results in anode expansion, that causes severe delamination.
107 Upon volumetric expansion, stresses are generated which are accommodated through the
108 creation of new surfaces and this results in the bowing of the anode away from the current
109 collector (Fig.1c-Fig.2). Interestingly, in a few locations the anode maintains good adhesion
110 with the current collector allowing the anode to continue to function; however, *in-operando*

111 imaging also shows that, during lithiation, delamination eventually results in areas of crack
112 propagation through the electrode thickness that reach the electrolyte. This is evident through
113 the 3D reconstruction (Fig.1b) where it is possible to see delamination leading to regions
114 where cracks propagate from the electrode-current collector interface through to the surface
115 of the electrode. The local electrode-current collector adhesion would influence this
116 behaviour. Over an operational lifetime, coalescence of cracks would therefore result in loss
117 of active material and hence capacity loss. The 3D data also shows the presence of intrinsic
118 porosity within the silicon electrode, although this accounts for < 1 vol %, these pores are

122 Radiograph images during lithiation, at $100\mu\text{A}$ (current density of 2.4 mA/cm^2) show the
123 delamination of the silicon electrode from the copper current collector (Fig.1c-Fig.2a). The
124 height of the delamination continues to increase with charging time, as does the width but at a
125 reducing rate. From the measured voltage data a rapid decrease in the cell potential is
126 observed, suggesting that the electrode-current collector contact resistance is increasing due
127 to the volumetric expansion caused by lithiation. After 500s the potential of the cell slightly
128 decreases until reaching 1500s. An increase in the available active surface area caused by
129 delamination may be responsible for this. Though 3D data analysis the electrode-current
130 collector contact area decreases as a result of delamination by 1.84 mm^2 from an original
131 4.17mm^2 which is equivalent to a 44.1% loss of contact area (Fig.1c). Concurrently, the

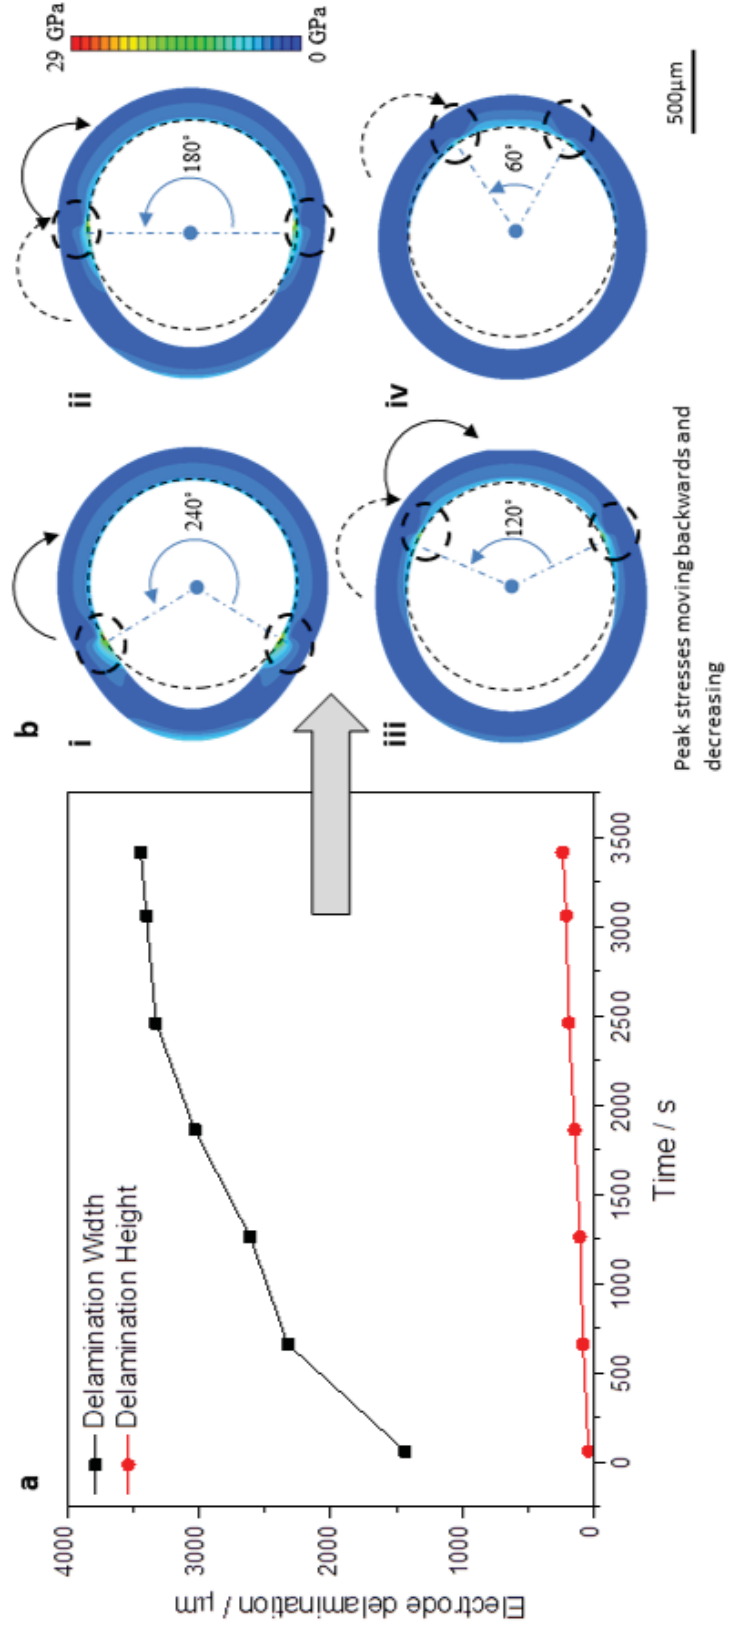
208 **Figure 2.** a) Radiography based anode delamination and, b) 2D simulation of anode expansion with varying fixed boundary
209 positions showing decreasing peak stresses with decreasing contact angle corresponding to increased delamination.

79 An analogous 2D finite element model of the electrode was setup using Abaqus CAE to
80 simulate stress distributions in the anode through lithiation induced volume expansion. The
81 model was run in standard FE solver mode, with the assumption that 100 µA for 3500s would
82 lead to a calculated 63 % volume expansion, and the silicon anode was isotropic, linear and
83 elastic. An elastic modulus of 100 GPa and Poisson's ratio of 0.26 were used (11, 12).
84 Several simulations were run with the anode circular interface fixed at angles from 240°, 180°,
85 120° and 60° respectively. The remaining part of the anode was allowed to move away from
86 the current collector on volume expansion to follow the observed direction and effect of
87 delamination (Fig.2).

137 From the imaging results it is clear that lithiation induces electrode delamination. Simulations
138 reveal that regions of the electrode fixed in contact with the current collector experience
139 greater stresses (Fig.2b). The peak stresses occur at the beginning of the delamination
140 void-current collector interface for all simulated angular positions. These positions correspond
141 to the delamination crack tip in the imaging experiments, and delamination would therefore
142 facilitate reducing stresses at the electrode-current collector interface. The imaging data
143 suggests electrode delamination is not linear with time and interestingly, the modeling shows

144 that peak stresses decrease with decreasing angular position. A decrease in peak stresses
145 could result in lower delamination rates with time. The present simulation is over-constrained,
146 since stress relaxation simulations are beyond the scope of present work. Once these are
147 considered then lower predicted peak stresses would be expected; however current values
148 are of the same order of magnitude as those in literature (12), and most importantly similar
149 trends are still expected to occur.
