# **A study into the origins and significance of white etching cracks in bearing steels**

A thesis submitted to the University of London in fulfilment of  
the requirements for the degree of Doctor of Philosophy and  
Diploma of Imperial College

Tribology section  
Department of Mechanical Engineering  
Imperial College London

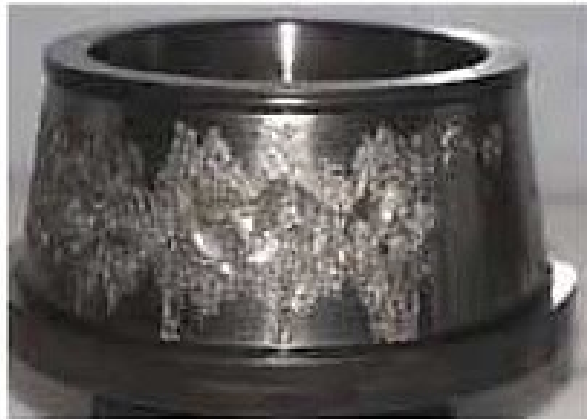
**Figure 9 Surface damage on an inner ring of a wind turbine tapered roller bearing [48]**

Other than the RCF related issues mentioned in the related section, there are several other reasons that could co-operate to drastically reduce the performance of a bearing and damage on raceway (see Figure 9); these being related mainly to poor lubrication, environmental action, cleanliness and residual stresses of the steel.

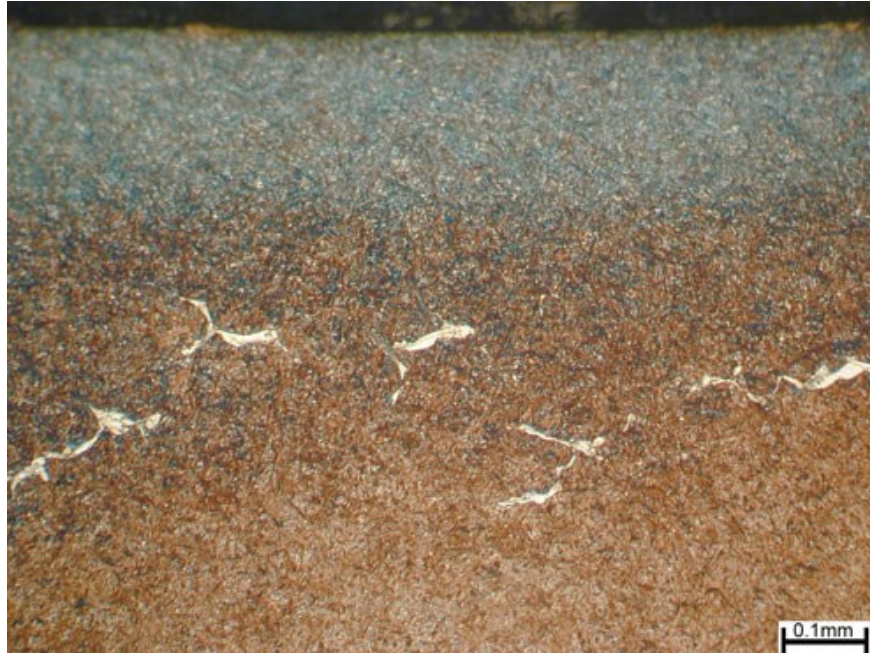
Figure 19 White etching areas around cracks in a rotor bearing from the field [13]

The term white etching area refers to the altered steel microstructure decorating white etching cracks which appear white under an optical microscope after etching with Nital (a solution of 2% volume of nitric acid in methyl alcohol). Examples of WEAs are illustrated in Figure 19.

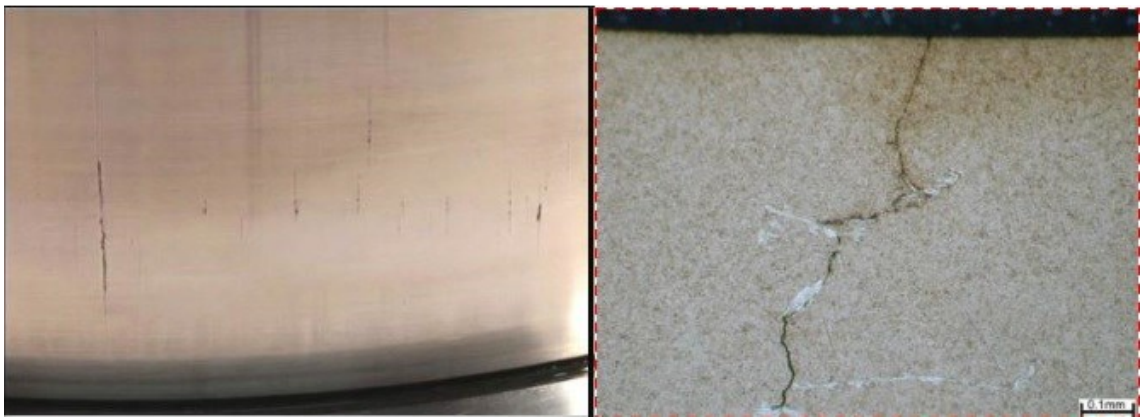
Figure 27 Axial cracks on an inner ring raceway (left) and in circumferential section (right) [13]

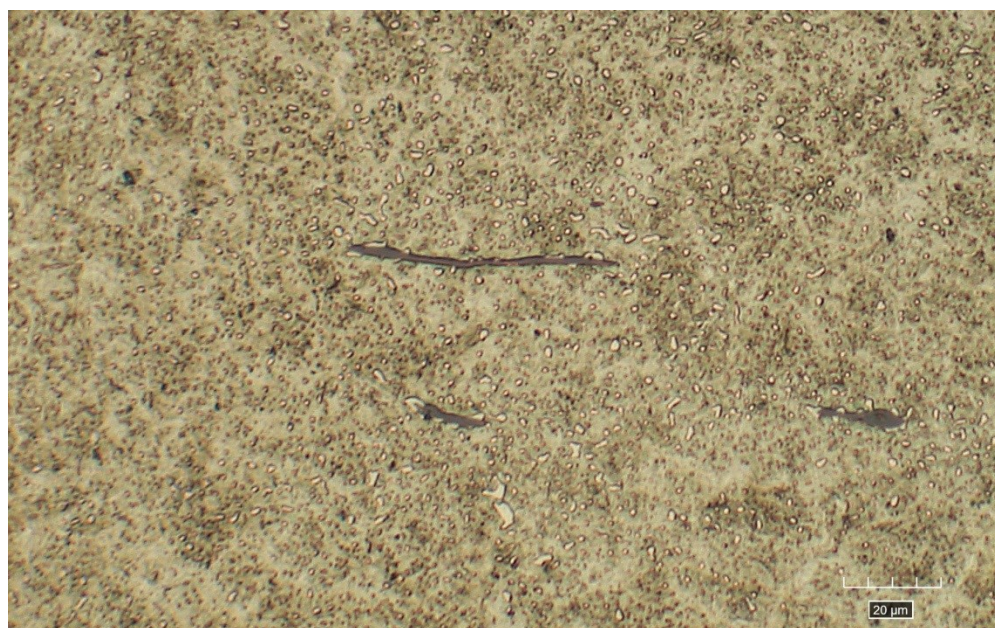
**Figure 40** Microstructure of the steel adopted in the present work is shown in a section parallel to the main axis of the roller. Presence of numerous carbides and non-metallic inclusions is reported

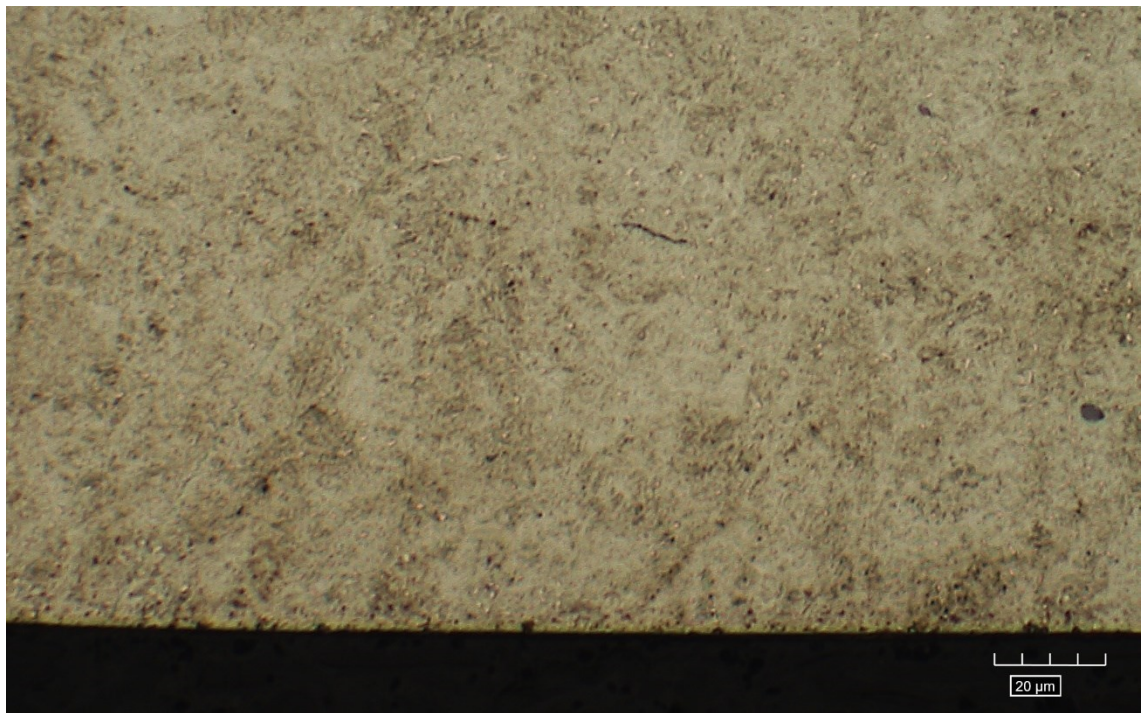
**Figure 42 Example optical image of an etched specimen cross-section. The etchant brings in evidence the microstructure of the steel, made of lath martensite, primary and tempered carbides and possible non-metallic inclusions**

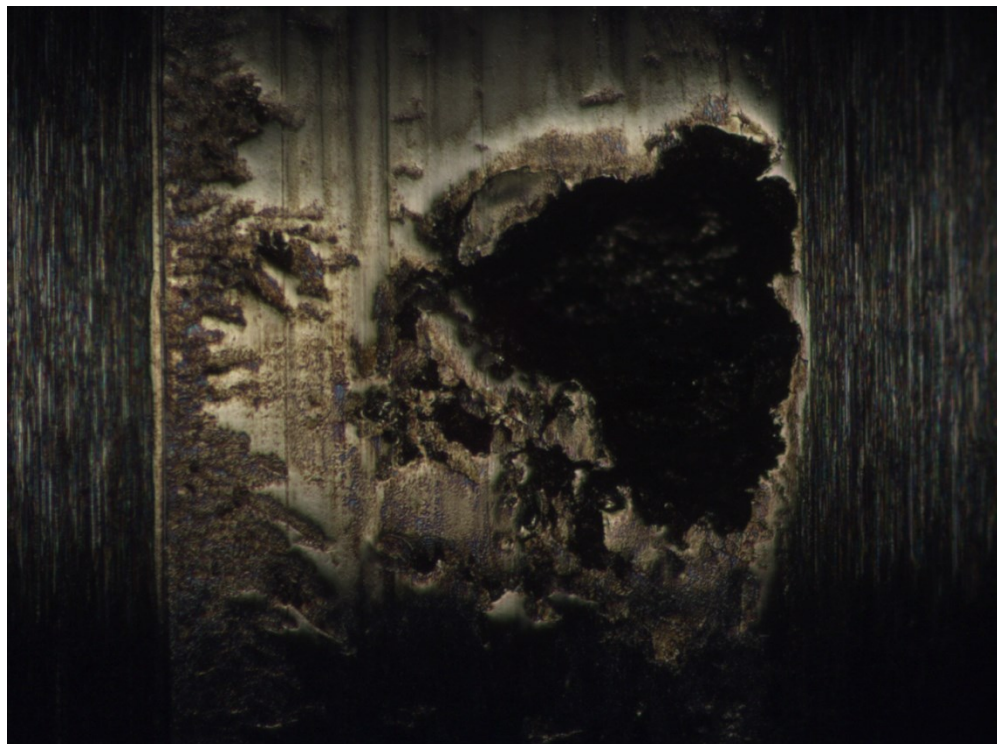
**Figure 45 The pitted surface of the roller after 23.3 million cycles in the preliminary test with commercial transmission oil.**

The roller specimen pitted after 23.3 million cycles. Figure 45 is an optical photograph that shows the final surface of the roller at the location of the produced pit.

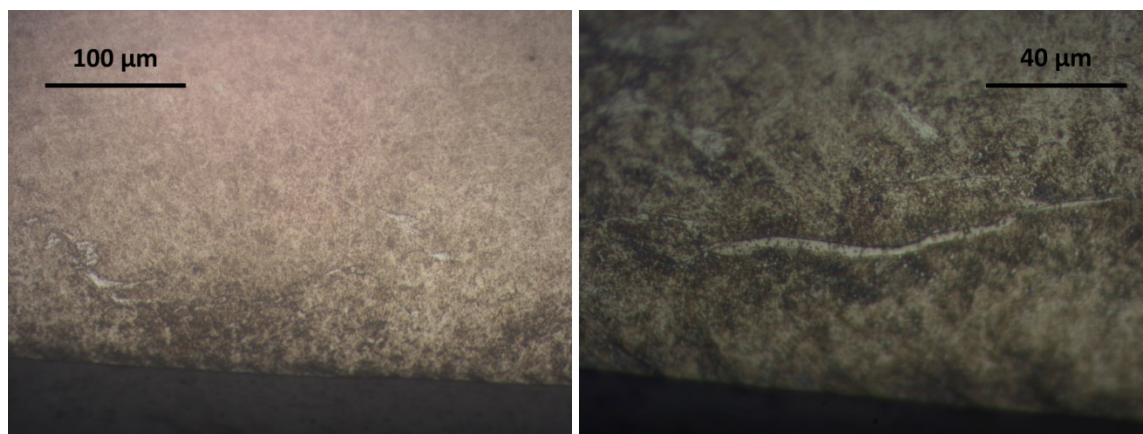
**Figure 56 Test 15: WECs observed in the sectioned specimen**

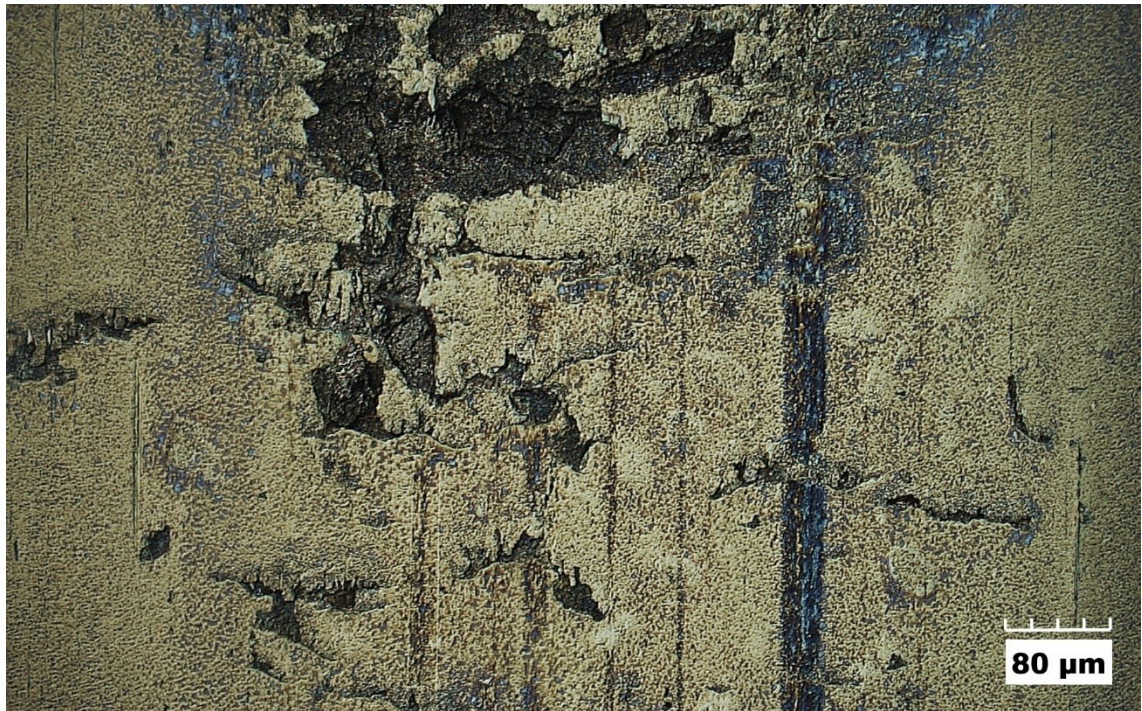
**Figure 103 Test 24: surface damage caused by the laser groove on the roller specimen after end of test, 30 million cycles.**
