# The Conservation of Doped-Fabric Aircraft at the Science Museum, London

Materials Department  
Faculty of Engineering  
Imperial College London

A thesis for a PhD degree

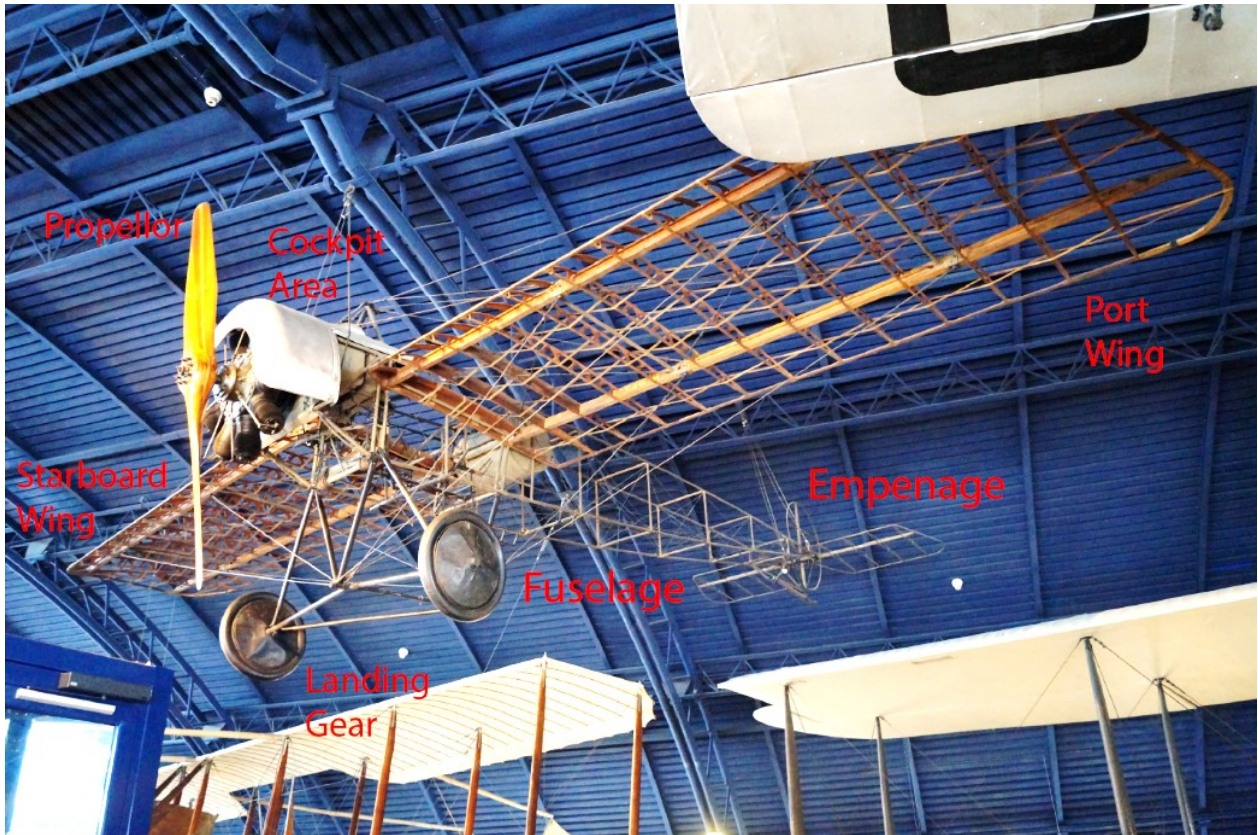
Figure 2-1: Annotated image of a Fokker EIII on display in *Flight* at the Science Museum

An aircraft may be broken down into three key sections (Figure 2-1), which are:

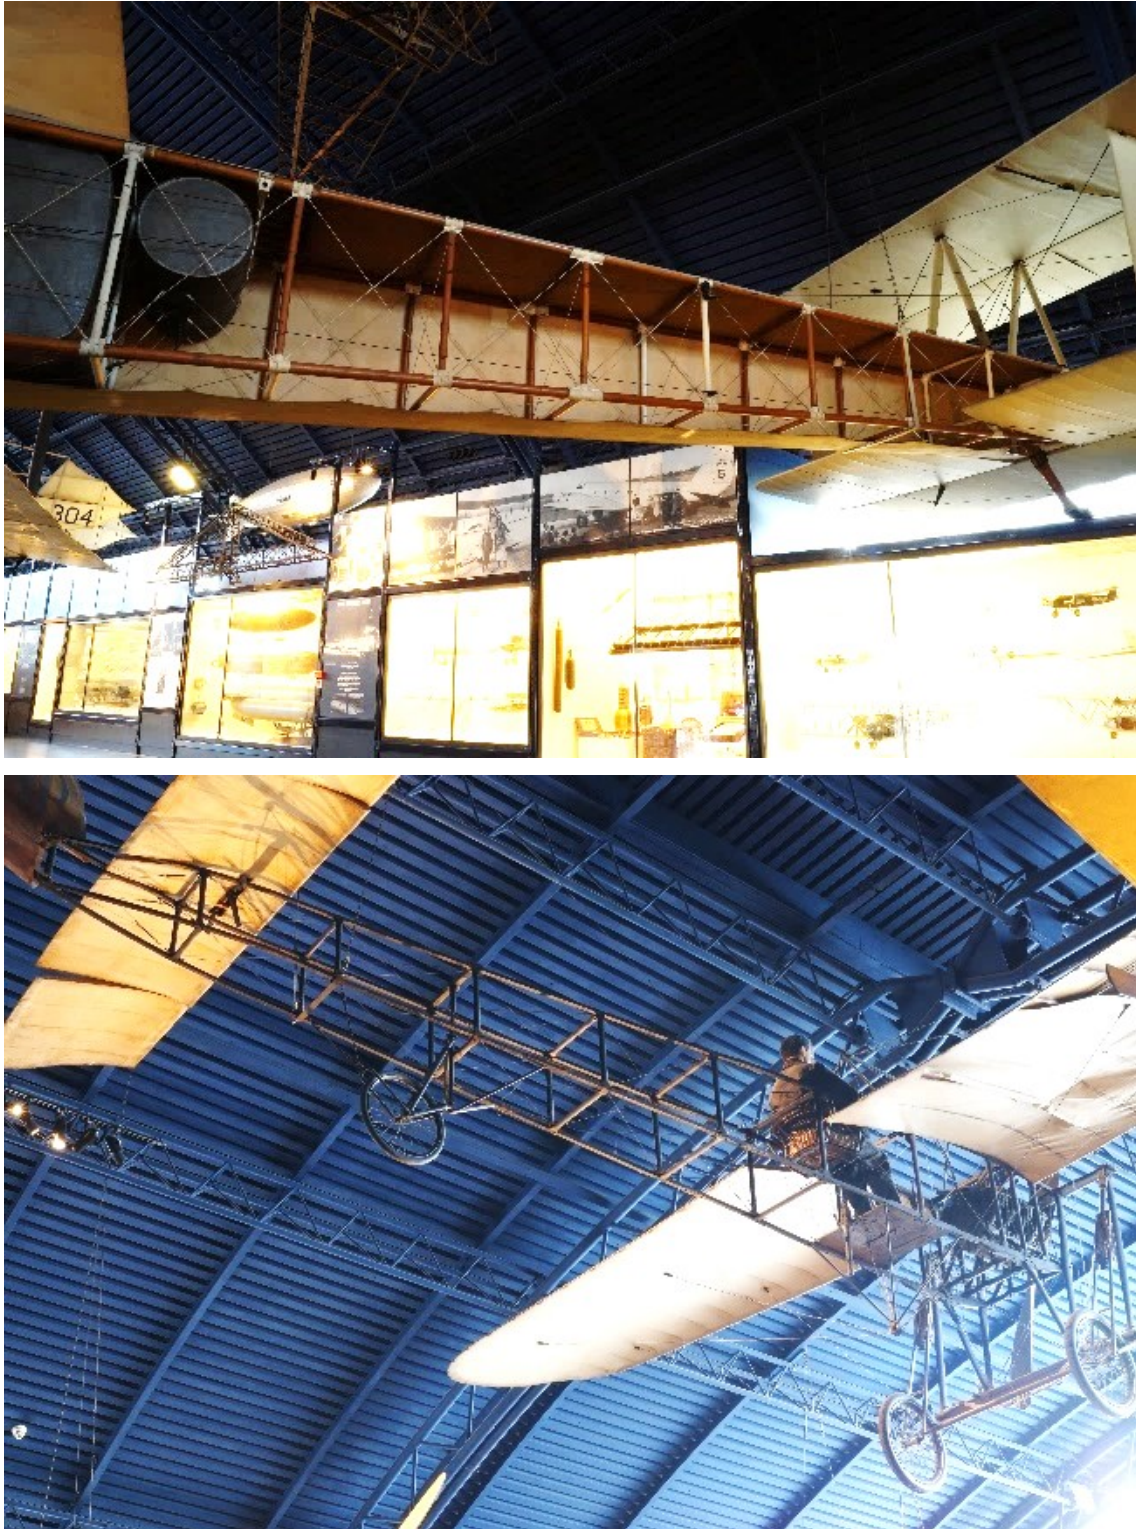
*Figure 2-2: Aircraft fuselages on display in *Flight* made using the truss method. The Vickers Vimy is shown above, the JAP Harding Monoplane below*

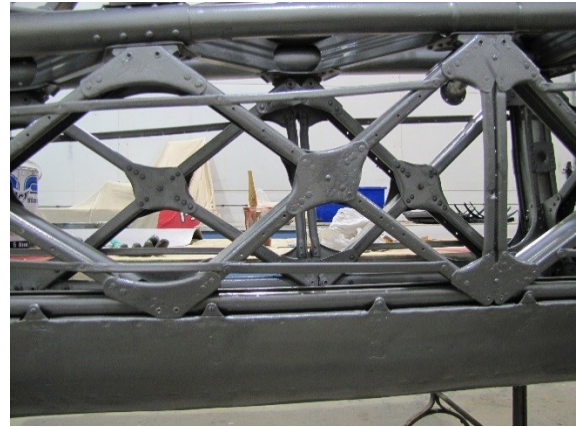
*Figure 2-11: The internal structure of a Wellington Bomber whilst being reskinned at RAF Museum Cosford. Small holes used for pinning the fabric in place are visible in the structure*

Alternative attachment techniques include the use of screws or pins and such methods were used increasingly for later doped-fabric aircraft, such as Wellington Bombers and Hawker Hurricanes, which reduced the time-consuming process of sewing. In a Wellington Bomber, the interior frame was designed with multiple pin holes throughout the metal structure, so that the fabric could be quickly and easily pinned down.

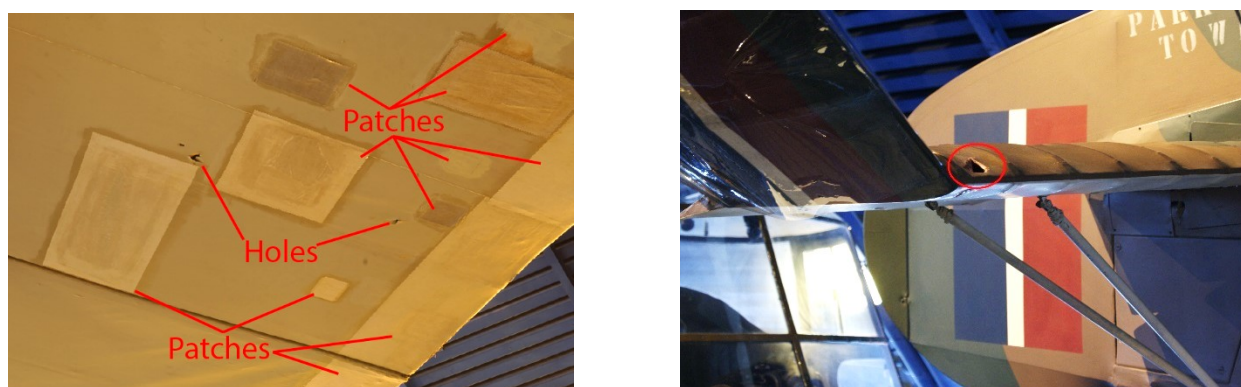
*Figure 3-2: Holes in the Vickers Vimy lower starboard wing (left) and Cierva C30a (right) potentially the result of human action*

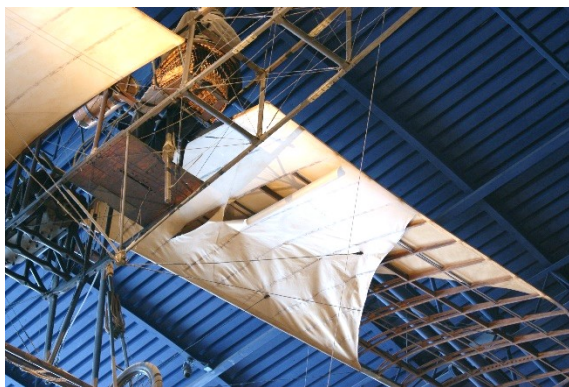
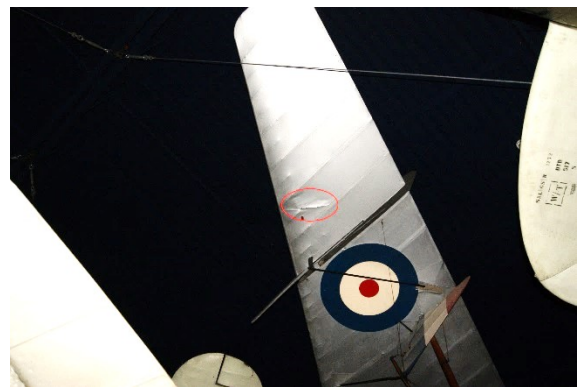
*Figure 3-5: Tears in the doped-fabric skins of the JAP Harding Monoplane (left) and the Pterodactyl (right) lying well beyond human interference*

These non-human induced tears, moreover, are visible in other doped-fabric surfaces, besides the Vickers Vimy. One tear in the JAP Harding Monoplane has opened the entire chordwise length of the starboard wing underside. Pictures from a 2008 cleaning project in the flight gallery indicate that there has been little change in the tear since the image below was taken in 2016. A similar, though less visible tear runs the full length of the Pterodactyl port wing, though there are no details as to how or when this occurred. Both of these aircraft are hung from the very top of the gallery ceiling, and so the tears seem highly unlikely to be the result of human interference.

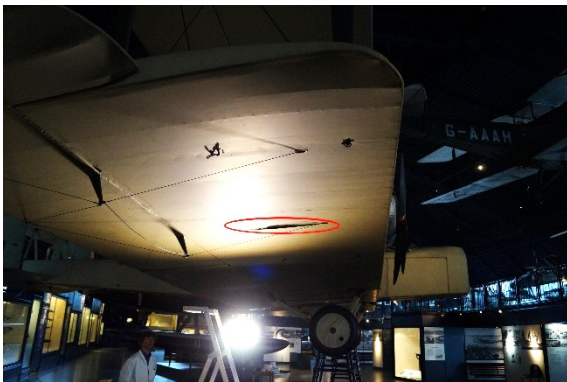
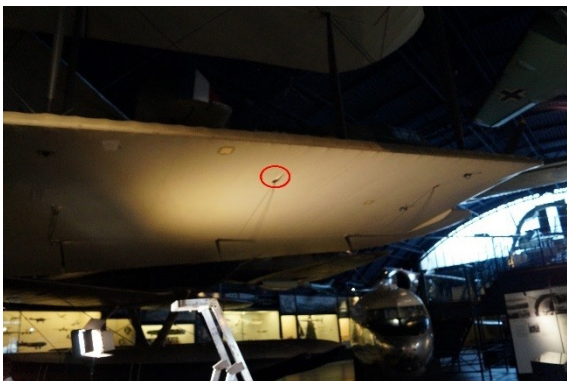
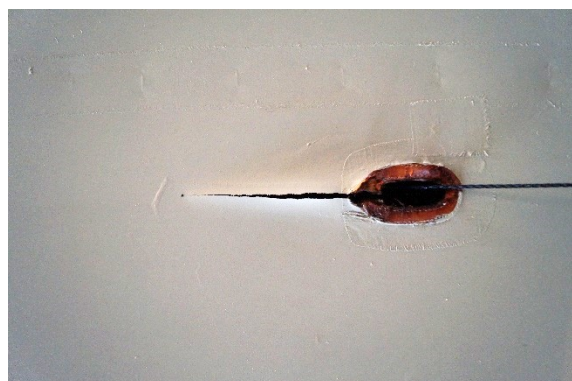
*Figure 3-6: Tears observed in the starboard (top) and port (bottom) lower wings of the Vickers Vimy. The images on the right record the tear when first observed*

Although potentially accessible from the ground, the location of the tears was towards the wing tips where the wings angle up from the ground sharply putting them beyond easy human reach and a ladder was required for access. Much less damage and patching is visible in these areas closer towards the wing tips than towards the fuselage.

The tears were first reported by gallery attendants who did not observe any visitor action which would have caused them and one end of both the tears was located near a defect in the wing, in both cases an eyelet where rigging passed through the skin, suggesting this was where the tear had first grown from.

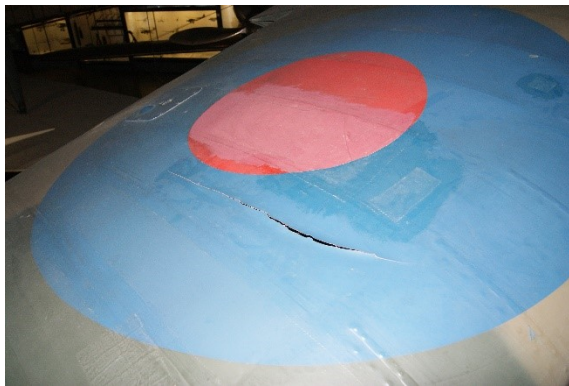
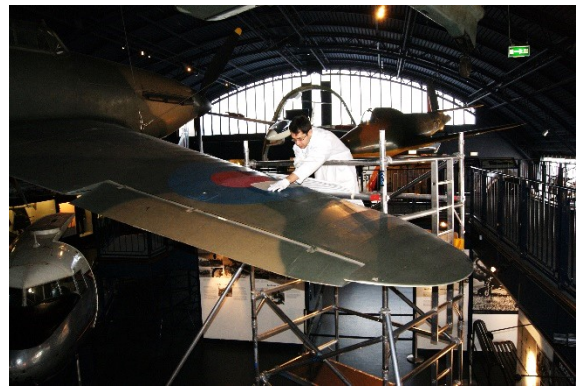
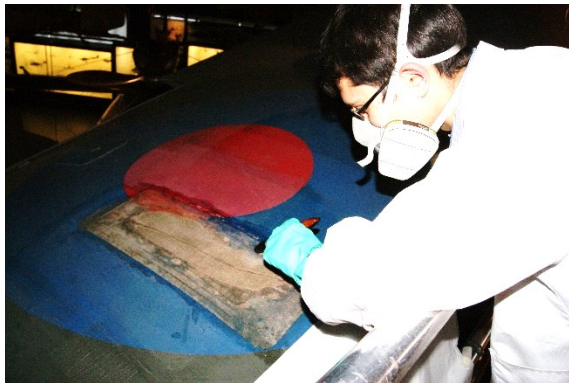
*Figure 3-8: The process of applying a dope-fabric patch to a tear in the Hawker Hurricane on display in *Flight*. Top left to right; a tear in the Hawker Hurricane; working at height to fit a linen patch to the tear area; applying dope to secure the patch in place; the tear seen from the walkway after in painting (images ©Richard Horton/The Board of Trustees of the Science Museum, London)*

following account of how aircraft doped-fabric patches are applied is based on first-hand experience working with the Engineering Conservator, Richard Horton (ACR), treating a tear on the Hawker Hurricane in 2013 during a student placement at the Science Museum (Figure 3-8).

The surface of the aircraft is prepared by first sanding the area over which the patch is to be applied to roughen the surface. This is then wiped with distilled water to remove any residues and create a clean surface. Once the size of the patch is satisfactory it is secured in place on the aircraft by application of a first coat of dope. This first coat is again a 50% solution in acetone, as was used to impregnate the patch, and is brushed on until the patch appears saturated. The edges of the patch are smoothed down constantly to ensure a smooth, strong adhesion to the substrate.

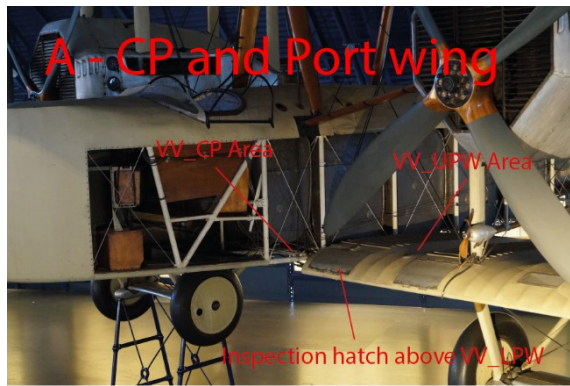
Figure 6-8: The location of strain gauges attached to the Vickers Vimy. From top left to right; (A) the locations in the Cockpit, upper port wing and lower port wing, (B) close up of the gauges attached to the upper port wing, (C) close up of gauges attached to the lower port wing, (D) the gauges attached to the lower starboard wing, (E) the location of gauges in the mid-Fuselage section, (F) close up of the gauges in the mid-Fuselage section

Five locations of the Vickers Vimy were monitored using strain gauges (Figure 6-8). Two of the areas were chosen as there did not appear to be any tears in the immediate vicinity and they could be monitored simultaneously. One location was an area of the fuselage to the rear of the cockpit, called VV\_CP, where access to the unpainted, inner side of the fabric was possible. Due to access difficulties from the surrounding aircraft structure the gauges had to be secured very close to the edge of the fabric where the cross-section had been cut away.

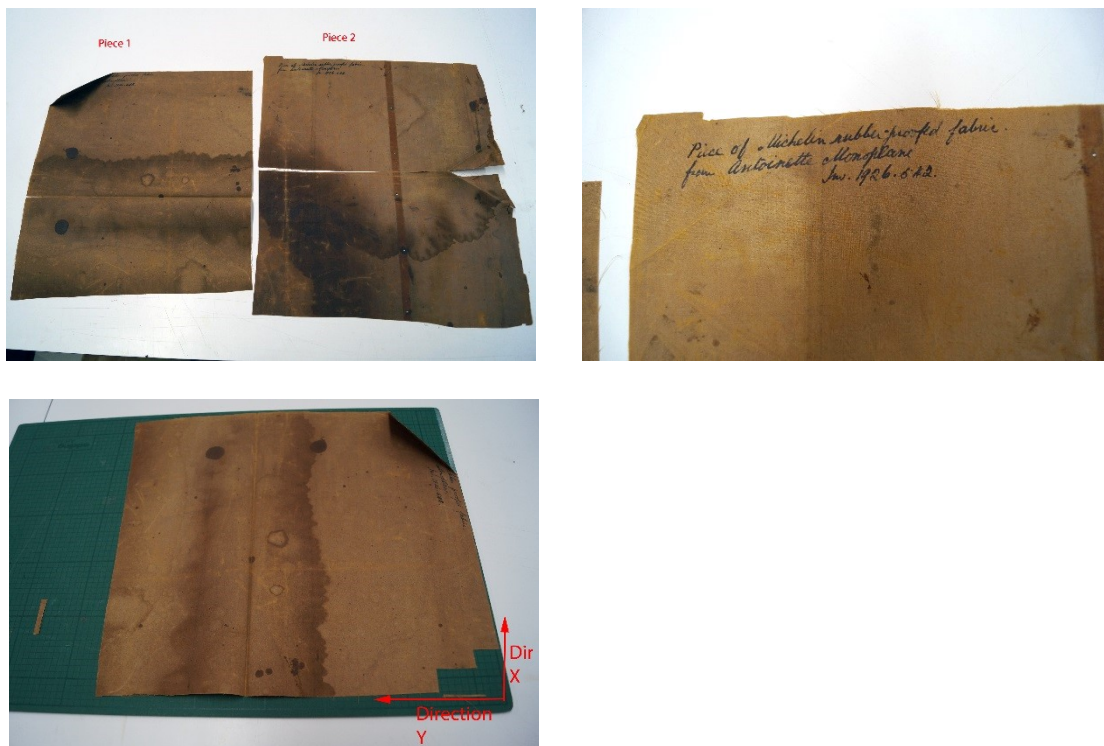
*Figure 6-9: Fabric samples from the Antoinette Monoplane Technical File*

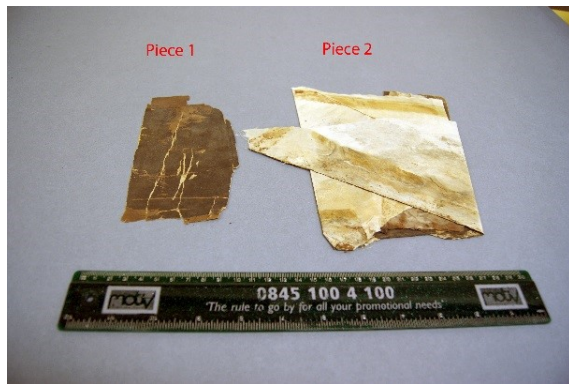
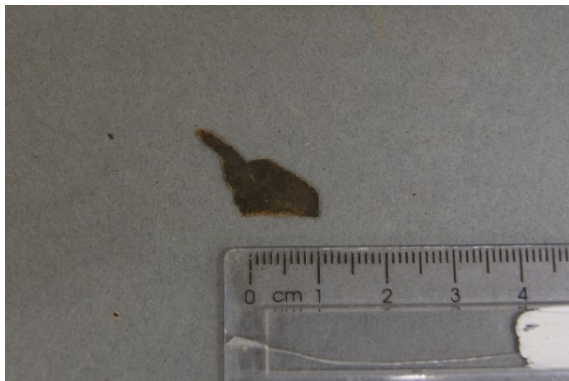
*Figure 6-11: Top: Fabric samples from the JAP Monoplane Technical File. Bottom loose piece of coating, JAP\_TF\_Pa, found in fabric folds*

Two separate pieces of fabric were found within the JAP Monoplane technical file within the same envelope. The first piece, JAP\_TF\_1, was a smaller, rectangular shape. It had a light to dark brown colour on one side, and was a more consistent dark brown on the other. This piece was very brittle and weak.

The second piece of fabric, JAP\_TF\_2, was irregularly shaped and heavily creased from being folded over itself. The surface finish of this piece of material was very inconsistent. A dark brown coating appeared to cover a large proportion of this fabric, but was delaminating in many parts. This coating visually appeared very similar to that of the other piece of fabric in the envelope. The piece of fabric was robust, though great care was needed in unfolding the creased sections to prevent further delamination of the surface coating. It is presumed that the side with the delaminating surface coating is the exterior. A loose piece of the brown coating was also found in the folds of fabric piece 2 which was retained for analysis and labelled JAP\_TF\_Pa.

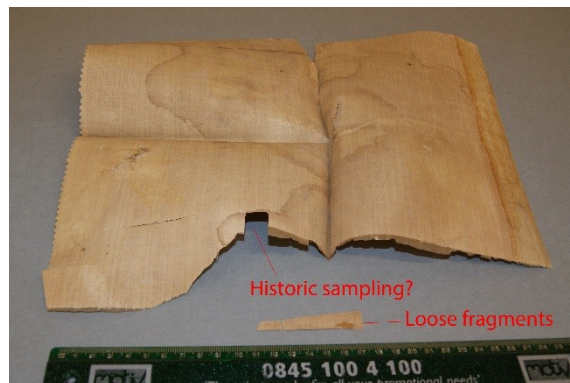
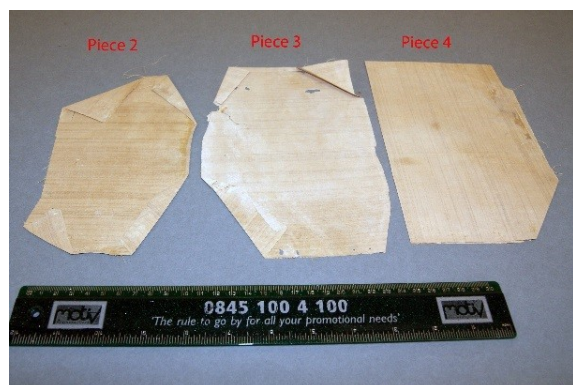
Figure 6-14: Fabric pieces from the Vickers Vimy Technical File. Piece 1 (top) was found in a separate envelope to pieces 2-4

A total of four separate pieces of material were found in the Vickers Vimy technical file. Piece one was found in its own envelope separate from the other fabric samples and had been folded so was heavily creased. It felt quite brittle when handled and was impossible to lie flat. One side was a dark, glossy brown colour, whilst the reverse was a lighter brown. There was a darker colour along one edge. Some smaller, detached pieces were also found in the envelope.

In a separate envelope three pieces of fabric were found of different sizes which were a much lighter colour compared to piece 1 and appeared to be similar on both sides. These were numbered 2, 3 and 4.

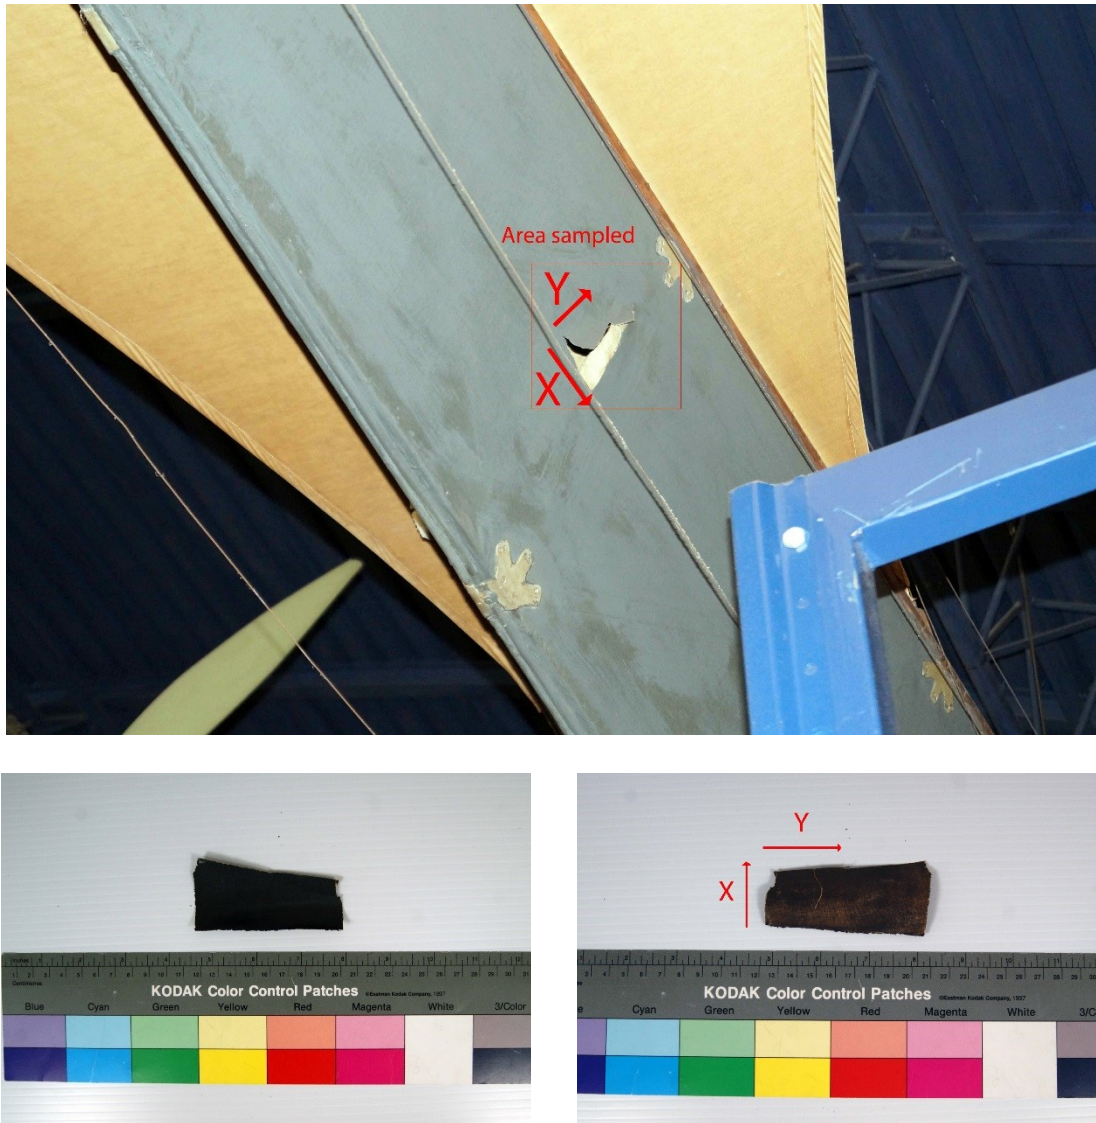
Figure 6-15: Fabric samples from the Antoinette Monoplane fuselage on display in *Flight* at the Science Museum

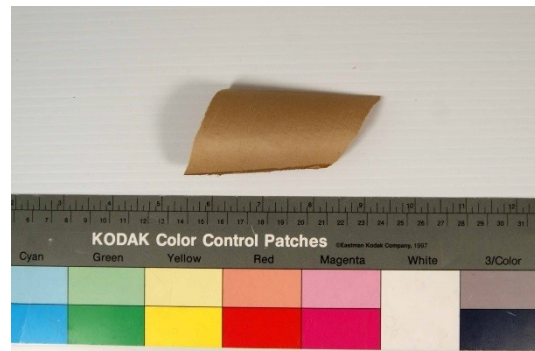
Figure 6-17: Location of damage and fabric samples from the JAP Monoplane on display in *Flight* at the Science Museum

A large tear had opened in the starboard wing running the length of the aircraft from the trailing end of which a rectangular piece was sampled. The sampling area was limited by access as work had to be conducted from a mobile lifting platform which could not approach close in due to the location of showcases. The piece obtained is heavily curled in upon itself, the exterior of the fabric being under compression and the interior under tension. The material is a light brown on both sides, though the exterior appears slightly darker than the exterior.

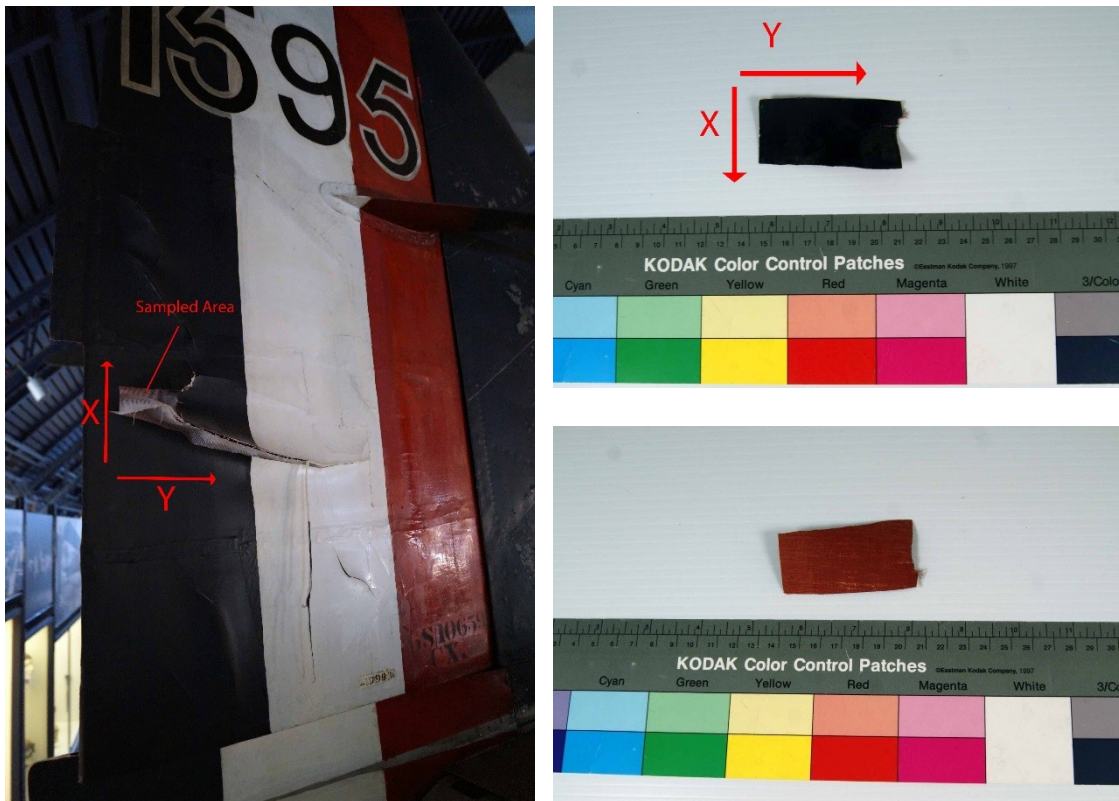
Figure 6-19: Location of damage and fabric samples from the Supermarine S6B on display in *Flight* at the Science Museum

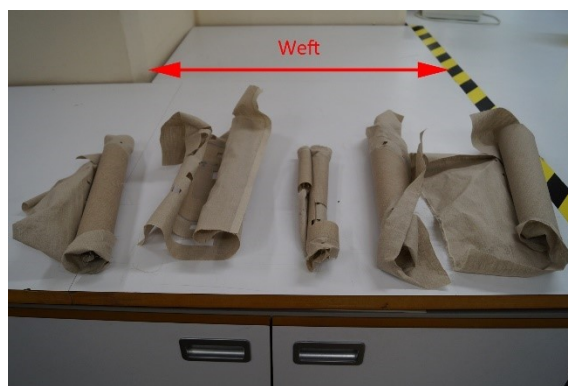
*Figure 8-1:* Doped-fabric panels of 9F1 Irish Linen treated with 9701 Randolph Butyrate dope after removal from the acrylic frame

Even before the use of SEM microscopy a few observations about the drying of the doped panels may be made. On removing panels of doped-fabric from the frames it was found that all panels curled up in the weft direction, with the doped side (exterior) under compression and the fabric side (interior) extension. No panels curled up in the warp direction on being released from the frames (Figure 8-1).
