**Analysis of Service-Retrieved TBC-Coated Industrial Gas Turbine  
Components**

**A Dissertation Submitted for  
MPhil Examination  
Imperial College London  
June 2010**

## Abstract

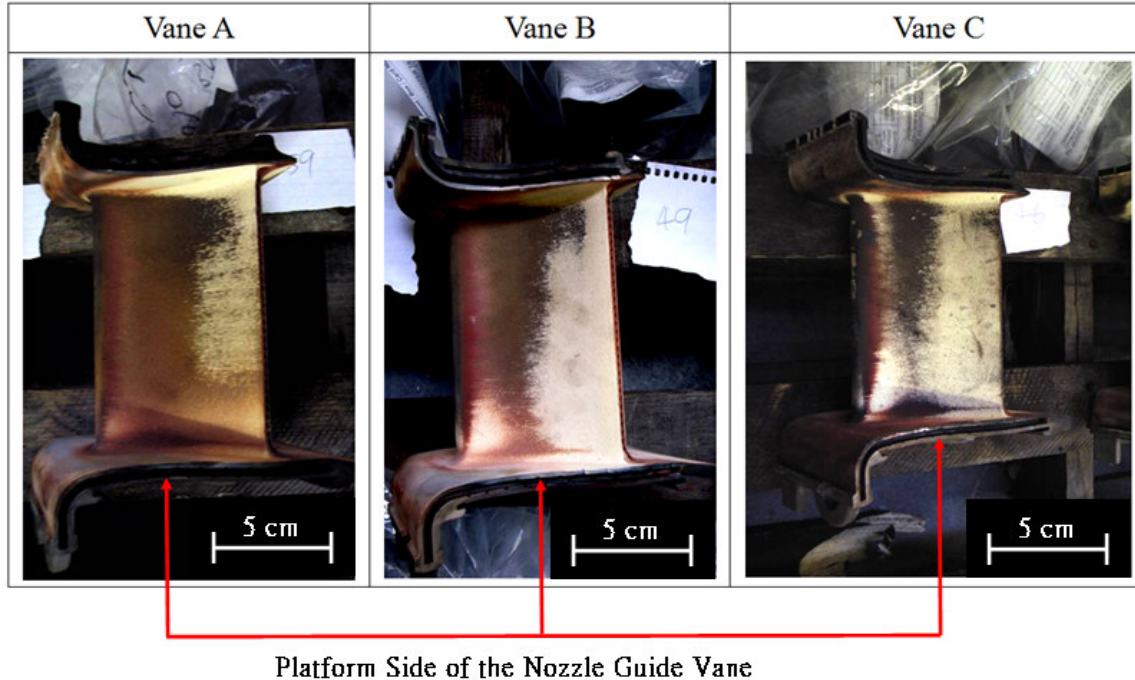
A modern combined cycle gas turbine (CCGT) power plant reported heavy surface contamination on the TBC coated nozzle guide vanes and blades. Three ex-service row one (R1) vanes have been examined. The three R1 vanes were removed from a Siemens V94.3 gas turbine after ~ 14,000 equivalent operating hours. This particular turbine consists of silo combustors feeding into the R1 vanes with a turbine inlet temperature of ~1160 °C. Since the gas enters the R1 vanes in a swirl, some vanes experience hotter gas temperatures than others. The amount of discolouration on the vanes varies, and three vanes were selected showing marked differences in their surface discolouration. Dense black colour deposits were observed on the pressure side leading edge and trailing edge,

whereas red and brown deposits were present on other pressure side surfaces. Vane A, B, and C (Figure 20) were chosen to represent the variation of possible temperature profiles based on their geometric arrangement in-plane. In addition, in some cases the distribution and variation of these coloured deposits show marked differences along cooling channels on a single vane indicating that the deposit (or the deposition process) is strongly affected by temperature.

Figure 20 Images of Vane A, B, and C with the pressure sides facing upward

Pressure side images of Vanes A, B, and C are shown in Figure 20. The TBC surface discoloration as observed by visual inspection varies dramatically between the vanes: Vane A had most of its surface covered (approx 75 % surface area) by the deposit, Vane B 50% and Vane C had the least (approx 35 %). The discoloured areas reveal dark / light brown, red and black deposits on all three vanes. Dark / light brown deposits tend to cover most of the area on the pressure side. Red deposits can only be seen near the pressure side leading edge. Lastly, black deposits are observed on both the pressure side leading edge and trailing edge. By looking vertically, fewer deposits appear to be accumulated near the platform side. Vane C, which reveals the highest ratio of black deposit, has TBC coating spallation observed at its pressure side leading edge, as shown in Figure 25.

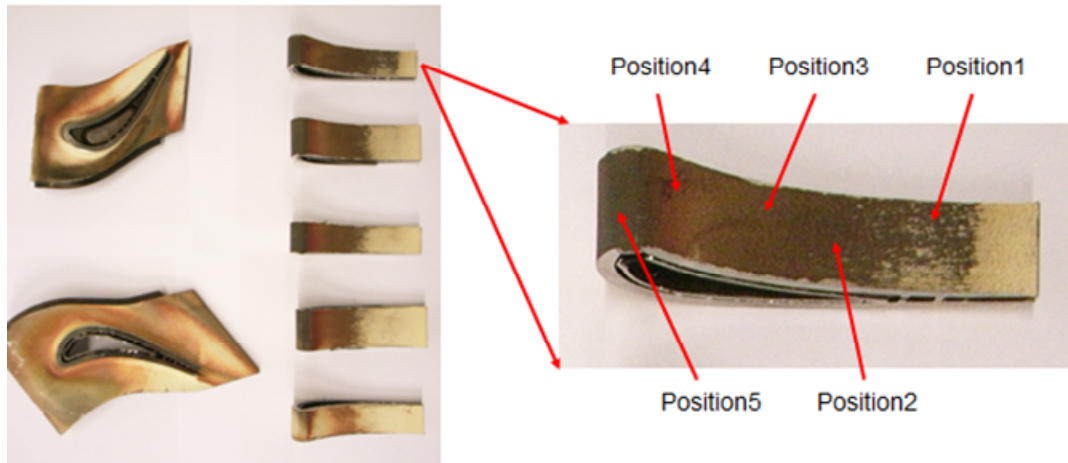
In order to better understand the deposit chemistry and morphology, a range of analysis techniques were used. Surface and cross-sectional scanning electron microscopy (SEM) were conducted on five selected positions across the pressure side of the discoloured nozzle guide vane. Figure 24 illustrates position 1 to 5 on a sectioned body piece from Vane B. This particular specimen has 4 different colours of deposits across the pressure side: black (position 1 and 5), light brown (position 3), dark brown (position 2), and red (position 4). SEM examinations were performed using a field-emission-gun scanning electron microscope (FEGSEM; LEO Gemini). The in lens secondary electron mode was employed to reveal the surface morphology of these deposits. Images were generated with an accelerated voltage of 5 kV with a working distance of 7 mm. For cross-sectional images of the deposits, backscattered electron mode (BSE) was selected to show the atomic number contrast within the deposit layer. Oxford Instruments ISIS EDS was used to perform surface and cross-sectional mapping to determine the elemental composition and distribution within the deposits.

Figure 24 Areas selected for SEM examinations

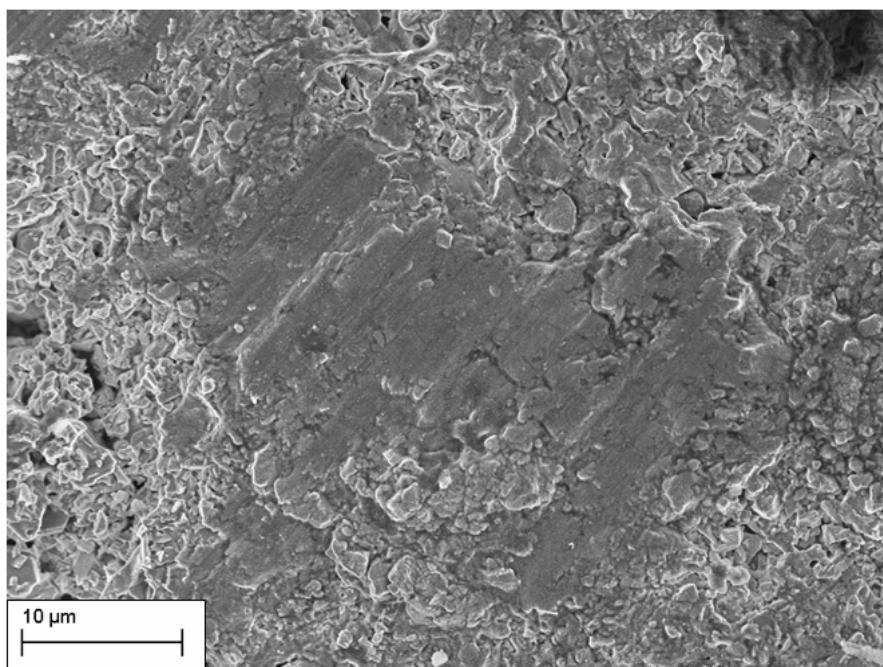
Surface SEM imaging on the deposit has revealed several surface morphologies. The most commonly observed surface structures were granular and flagstone-like plates (Figure 27 and Figure 28). The size of the granular particles was relatively uniform, ranging from 2 to 4  $\mu\text{m}$ . The flagstone-like plates, on the other hand, had much more variation in size with typical plate sizes ranging from 3 to 10  $\mu\text{m}$ . For the larger plates, a horizontal ridged surface was also observed. Consolidated regions (Figure 29) and needle-like structures (Figure 30) were also observed; however, these microstructural features occupied only a minor fraction of the total surface area analyzed.

Figure 29 Large area of consolidated region on top of granular layer: SE image

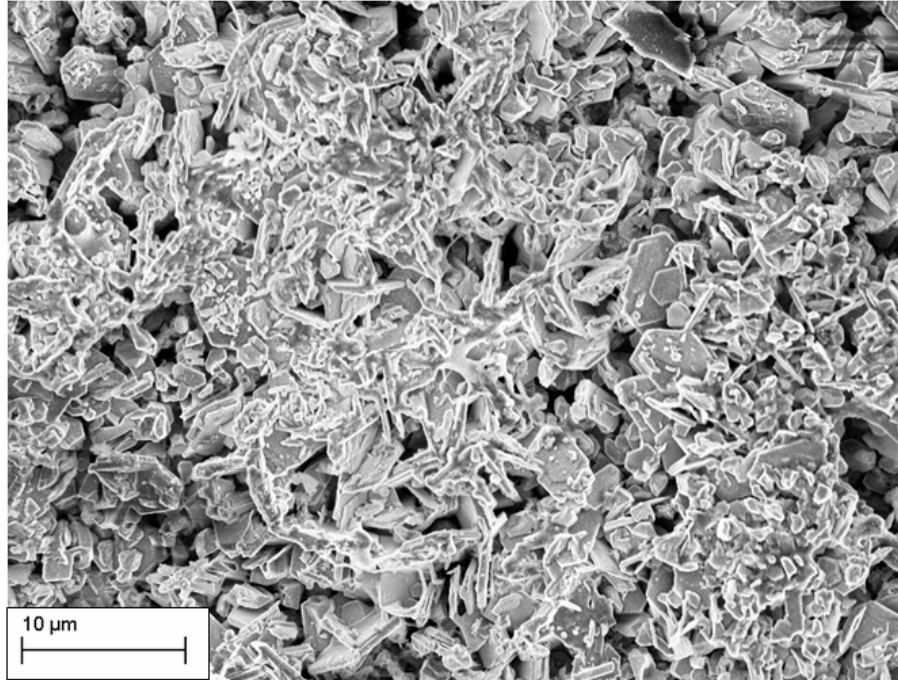
Figure 30 Needle-like structure surface observed in lighter colour deposits: SE image

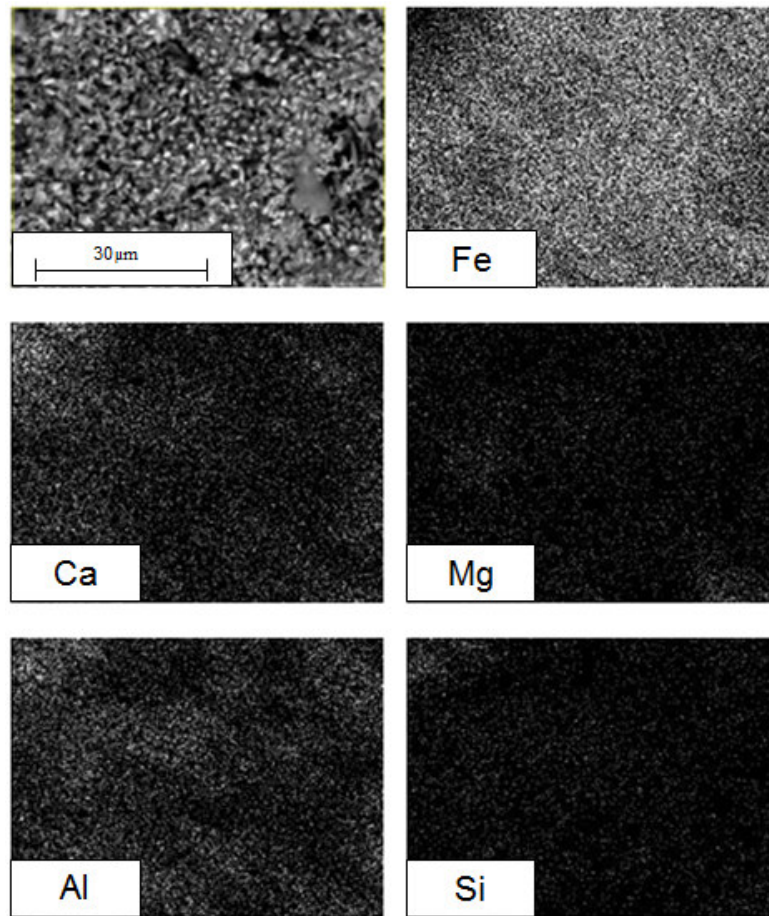
As for chemical composition, surface EDS mappings have detected iron with traces of calcium (~5 atomic %), magnesium (~1 atomic %), aluminium (~5 atomic %), and silicon (~1 atomic %). The calcium, magnesium, aluminium, and silicon sources are primarily sand and dust particles which pass through the filter system from outside. It was first suspected that these elements form the CMAS (calcium-magnesium-alumino-silicate), which is commonly reported in aerospace and most land-based gas turbine applications [2, 3]; however, the EDS results from Figure 31 and Figure 32 do not provide enough evidence for this assumption due to the trace amounts of Mg and Si. This particular CCGT avoids environmental attack by CMAS through the use of efficient air filters which block most external impurities.

Figure 31 shows the EDS mapping of a granular surface from a light brown coloured surface. Results indicate the presence of calcium, magnesium, aluminium, and silicon in combination with much larger iron signals. On the other hand, mappings of the black deposits covered by flagstone surface structure are shown in Figure 32. Figure 32 reveals high intensity of iron as well as some calcium and aluminium contents. The calcium, and

Figure 31 EDS Mapping on granular surface reveals the chemical composition and distribution of Fe, Ca, Mg, Al, and Si, the top left presents an SE image of the mapped area

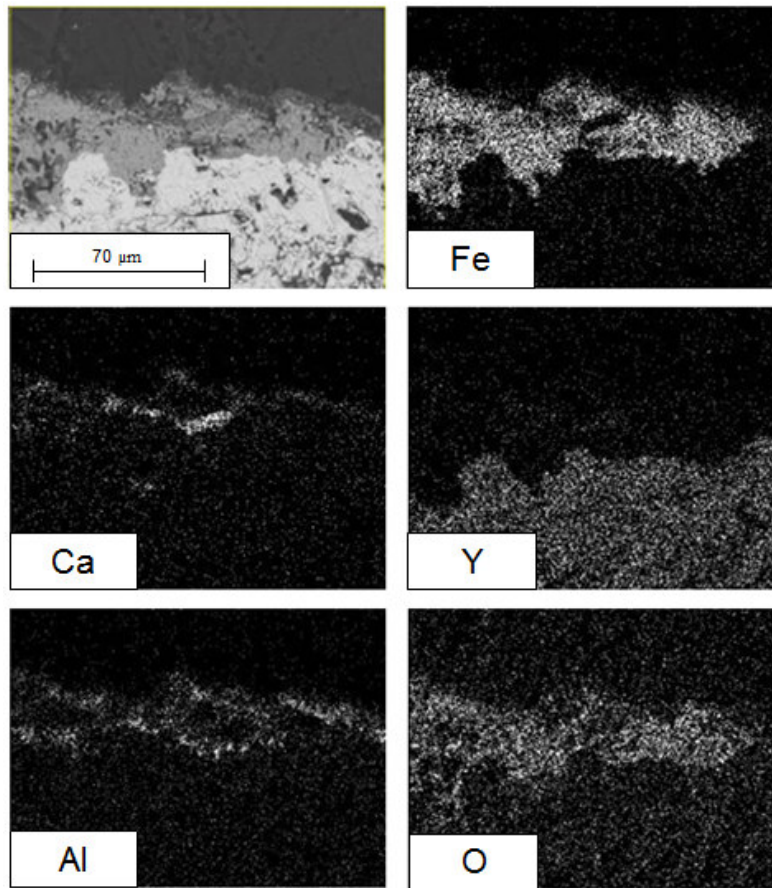
Cross-sectional EDS analysis examined the chemical composition and distribution of the contamination deposit. EDS mapping again reveals high iron content ( $\sim 30$  at%) with a minor trace of calcium ( $\sim 2$  at%) and aluminium ( $\sim 5$  at%). Figure 41 shows the EDS mapping of a light brown deposit site. Calcium and aluminium were observed near the surface and the deposit / YSZ interface, whereas the bulk of the deposit is primarily iron oxides. The calcium and aluminium appear to be inhomogeneous, suggesting the existence of two different compounds. For comparison, an EDS map of a dark brown deposit is shown in Figure 42. Minor calcium and aluminium signals were again detected from these dense regions. In the study of other environmental degradation, yttria extraction was reported. Stott et al have shown that in the case of CMAS attack, yttria content could be reduced in the YSZ top coat [17, 23, 31]. However, for these particular iron oxide deposits, EDS mapping reveals no sign of yttria extraction within the sensitivity of the measurements.

Figure 41 EDS mapping on the cross-section of light brown colour deposit site

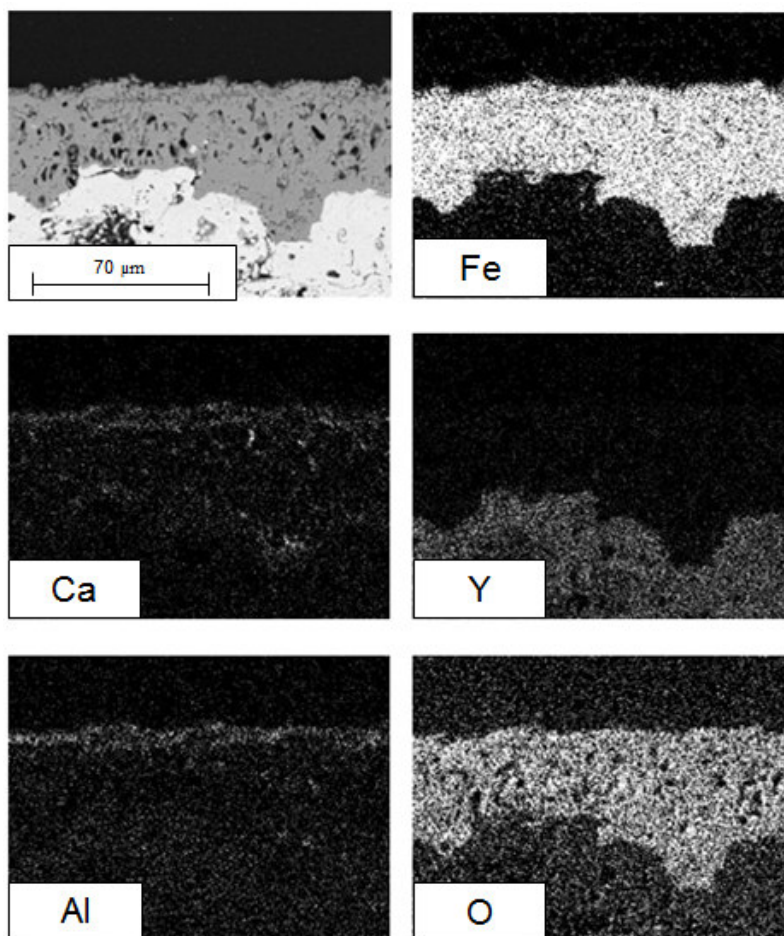
Figure 42 EDS mapping on the cross-section of dark brown colour deposit site

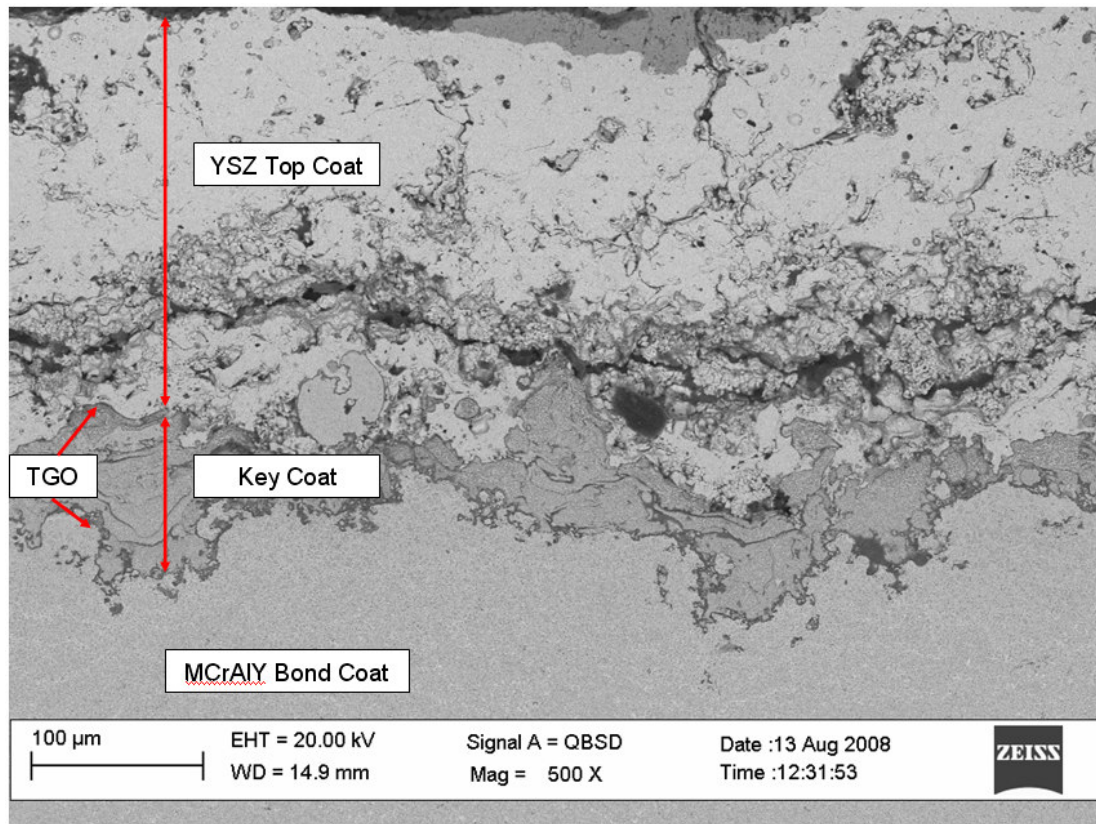
TGO measurements of Vane A reveals no significant change in TGO thickness (or temperature) from position A to B, whereas going from C to D, a significant increase in TGO thickness is observed. TGO measurement on Vane C (V3-A, V3-B, V3-C and V3-D) was not possible due to the presence of a key coat. The key coat is an additional coating between the top coat and the bond coat for better adhesion. When measuring the TGO with the presence of a key coat, the TGO layer is rather irregular and difficult to identify. Figure 53 is an example of TGO layers with the presence of a key coat; TGO layers form at the YSZ / key coat, key coat / MCrAlY interface as well as within the key coat itself, making it difficult to measure the TGO thickness.

Figure 53 TGO layers with the presence of a key coat

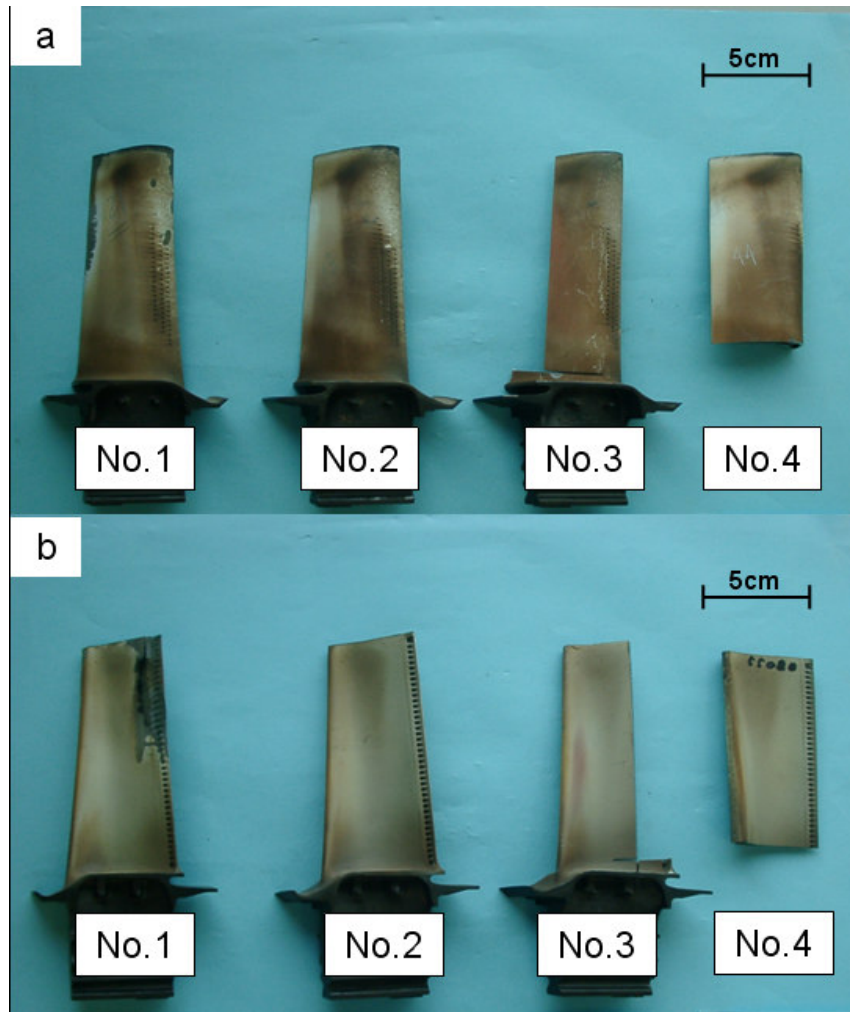
Four service-retrieved second stage blades received from a commercial airliner are shown in Figure 54. For these blades, spallation failures are observed, such as, the coating on blade #1 has already failed on the pressure side towards the trailing edge. Each service-retrieved blade was sectioned into 28 pieces (Figure 55) using Heiwa Fine Cutter and cross-sections of all the pieces were polished to 1 µm. Scanning electron microscopy (SEM) analyses on these samples were conducted using Philips XL30 SEM at 20kV. Images taken by the SEM were loaded into Image-Pro Plus (Media Cybernetics) for measurement of the average thicknesses of TGO and YSZ of all 28 pieces in a similar way as described in section 4.3 *Thickness measurements*.

Figure 54 Second stage turbine blades received a) pressure side, b) suction side

By looking at the blades visually, gradients of surface colours were observed (Figure 54). It was proposed that the colour gradients were linked to the temperature experienced. To gain insight into the operating conditions of the service-retrieved blades, TGO thickness across both the pressure and suction sides was first plotted to understand the temperature profile experienced by the 2<sup>nd</sup> stage turbine blades. Figure 56 presents maps of TGO thickness with complementary photographs of the pressure side and suction side. Boxes in red represent regions of thicker TGO, implying hot zones. Maps of TGO growth reveal that the temperature near the trailing edge is relatively higher. When the TGO plot of blade # 2 is compared with the visual appearance of blade #1 (Figure 57), it is clear that the high temperature regions match with the failure sites.

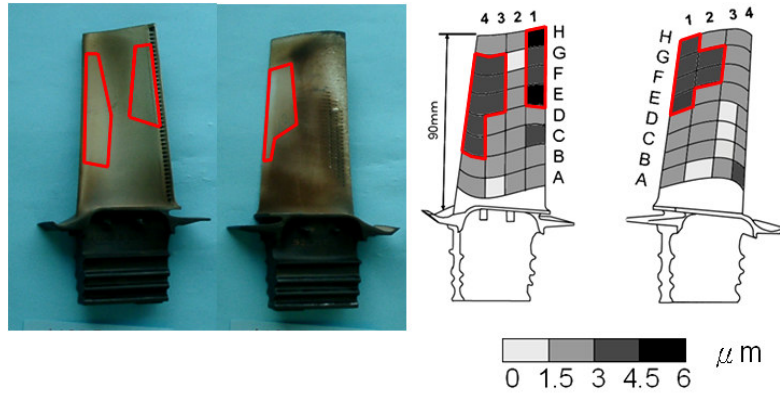
Similar to the TGO mapping, the surface color of the TBC was also translated into information about the TBC surface temperature. Regions without any discolorations (white surface) are usually hot; in these areas the surface temperature exceeds the melting temperature of the chemical deposits. In contrast, a dense surface deposit is observed from all four blades near the cooling holes on the suction side, suggesting cooler surface result in heavy discoloration. According to the heat treatment test results, Table 7 and Table 8, TBC surface color changed to white after 20 hours at 1150 °C. Therefore, the melting temperature of the deposits on this blade is between 1100 °C to 1150 °C. It was observed that TBCs next to the failure site have completely turned white (Figure 58); the surface temperatures in these white areas are expected to be (experiencing) 1150 °C or higher during service. It was unclear whether these 2<sup>nd</sup> stage blades were designed to withstand such a high temperature; however, it is certain that TBC surface color can be useful in terms of estimating relative surface temperature.

Figure 56 Comparison of TBC surface discoloration and temperature profile of blade #1

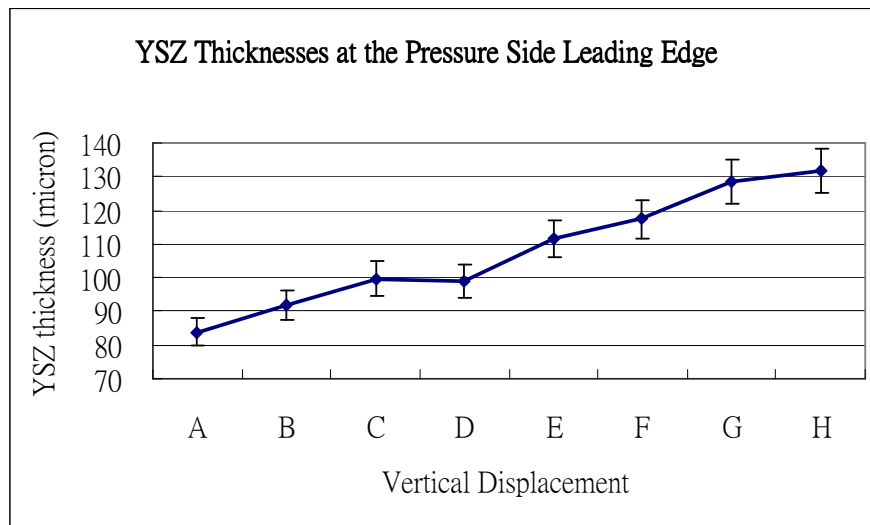
YSZ thickness measurements were recorded to understand the degree of erosion attack at potential failure sites, such as pressure side leading edge, trailing edge, and suction side leading edge. Figure 63 and Figure 64 present the YSZ thickness of pressure side leading edge and trailing edge respectively. Letters A to H on the x-axis represent each blade section (Figure 55), with section A being closest to the platform and H being the furthest. At the pressure side leading edge, the thickness gradient across the total vertical displacement is  $47.6\mu\text{m}$  with section A being the thinnest at  $92.1\mu\text{m}$  and section G being the thickest at  $139.7\mu\text{m}$ . Whereas, in pressure side trailing edge, the thickness gradient across the total vertical displacement is  $47.9\mu\text{m}$  with section A being the thinnest at  $83.9\mu\text{m}$  and section H being the thickest at  $131.8\mu\text{m}$ . The same trend was also observed at the suction side leading edge (Figure 65). According to the measurements done by Image-Pro Plus, YSZ coatings near the platform side of the blade were significantly thinner. It is known that the EB-PVD coating process generates a certain degree of thickness variation due to the geometry, but such variance should be minor. It is suspected thickness gradients result from different rates of erosion and the rates of erosion are related to TBC surface temperature. Unlike first stage gas turbines, second stage gas turbine blades experience a much lower temperature; such temperatures are very close to that of the CMAS melting temperature. Once the surface temperature

Figure 63 YSZ thickness recordings at the pressure side leading edge

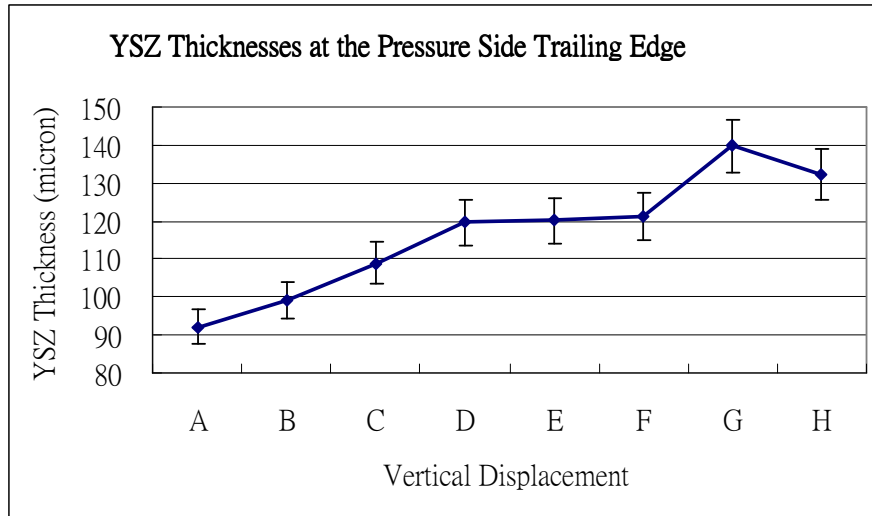
Figure 64 YSZ thickness recordings at the pressure side trailing edge

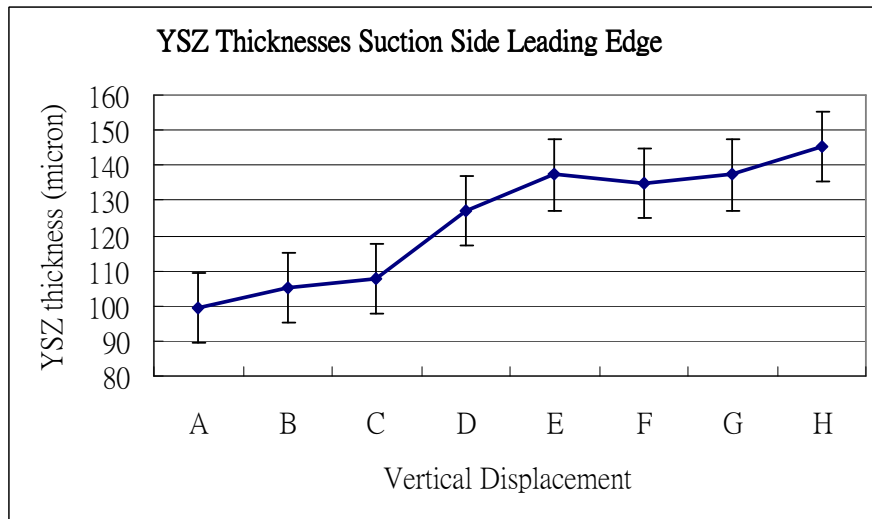
Figure 65 YSZ thickness recordings at the suction side leading edge

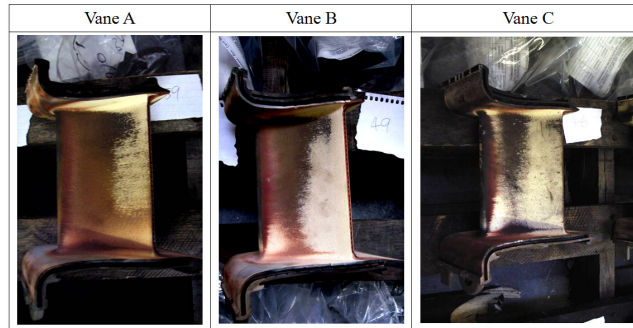
Pressure side images of Vanes A, B, and C are shown in Figure 2. The TBC coatings on these vanes were prepared by air plasma spraying method. The TBC surface discoloration as monitored by visual inspection varies dramatically between the vanes: Vane A had most of its surface covered (approx 75 % surface area) by the deposit, Vane B 50% and Vane C had the least (approx 35 % ). The discolored areas reveal dark / light brown, red and black deposits on all three vanes. Dark / light brown deposits tend to cover most of

the area on the pressure side. Red deposits can only be seen near the pressure side leading edge. Lastly, black deposits are observed on both pressure side leading edge and trailing edge. Vane C, which reveals the highest ratio of black deposit has TBC coating spallation observed at its pressure side leading edge, as shown in Figure 3.

Figure 2 Pressure side surface images of Vane A, B, and C

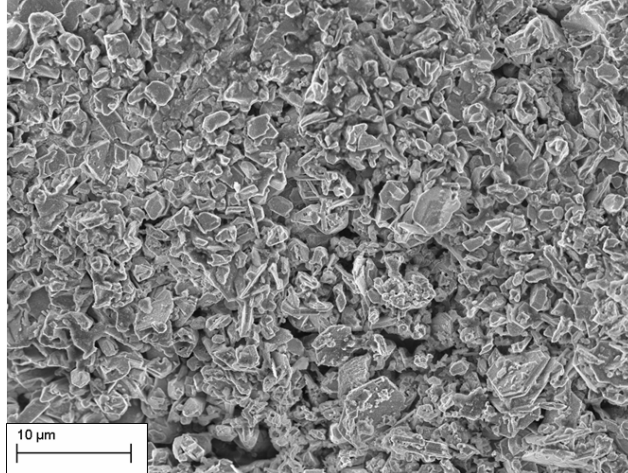
Figure 5 Granular structures on the commonly observed on the lighter colour deposit surface

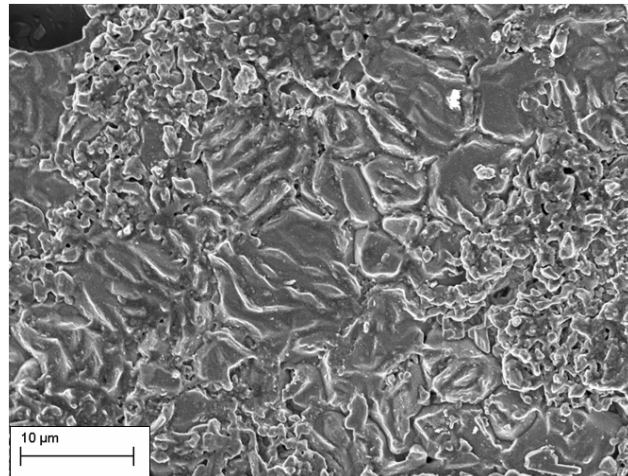
Figure 6 Flagstone-like plates commonly observed on darker deposit surface

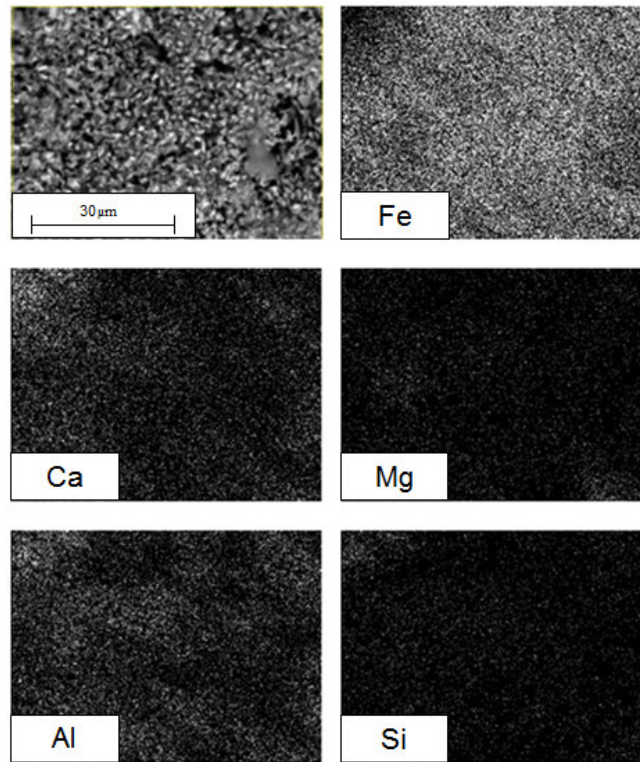
Figure 9 shows the EDS mapping of a granular surface from a light brown coloured surface. Results indicate signals of calcium, magnesium, aluminium, and silicon in combination with much larger iron signals. The flagstone surface structure shows high intensity of iron and oxygen. Figure 10 is the EDS mapping of the flagstone plate from a region covered by black deposit. Signals of calcium, magnesium, aluminium, and silicon come from the gaps and openings of the flagstone-like plates. It is therefore believed the

Figure 9 EDS Mapping on granular surface reveals the chemical composition and distribution of Fe, Ca, Mg, Al, and Si

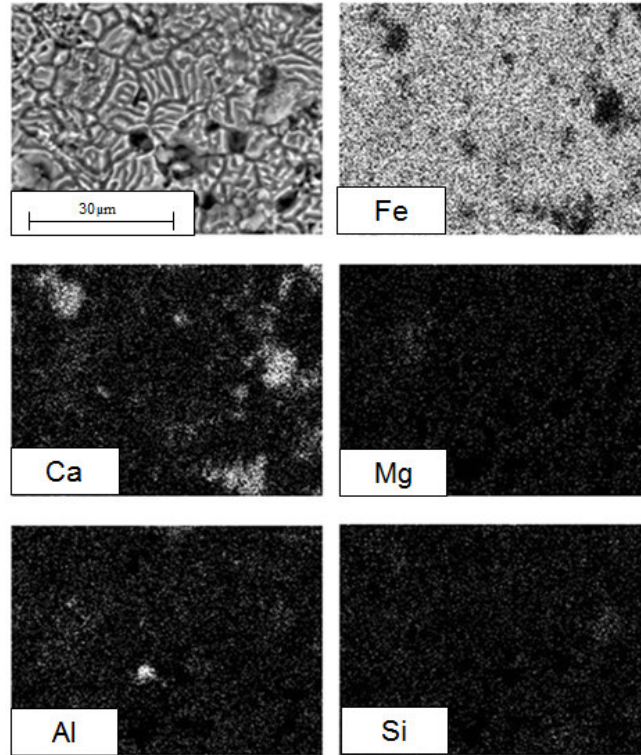
flagstone plates are iron oxide and granular particles are either a mixed Fe-oxides or multiphase grains.

Figure 10 EDS Mapping on Flagstone plate surface reveals mostly iron on the surface

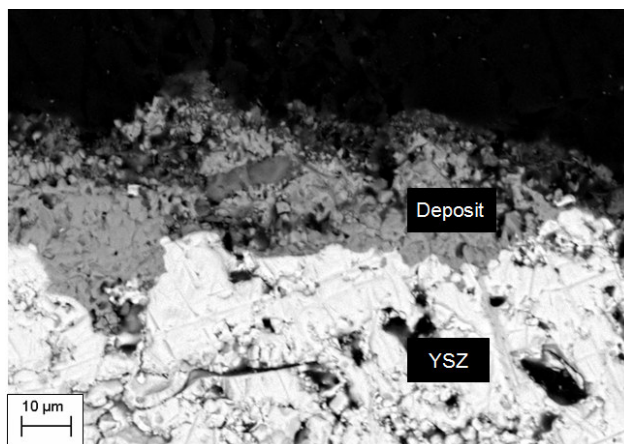
Cross-sectional analyses have been conducted on the various deposits. Figure 11 and Figure 12 show the light brown and red deposits respectively. A large amount of voids were observed within these deposits. The back scattered electron mode (BSE) images also revealed multiple phases within the deposit layer such that a dense, high atomic number layer exists at the outer most layer of the deposit. This outer layer is not uniform in thickness and has a granular structure. It is confirmed from the surface SEM that granular structure dominates the surfaces of lighter colour deposits (light brown and red). These cross-section images revealed that the granular layer is only a thin layer on the surface while a compact layer lies underneath. The granular layer shows high BSE - contrast, indicating the presence of high atomic number elements.

Figure 11 Cross-sectional SEM of light brown deposit

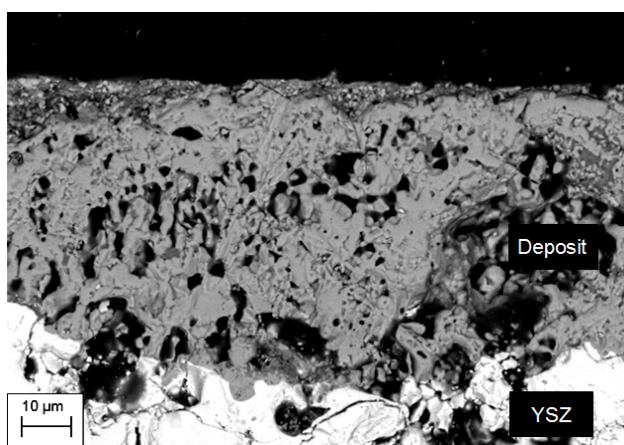
Figure 12 Cross-sectional SEM of red deposit

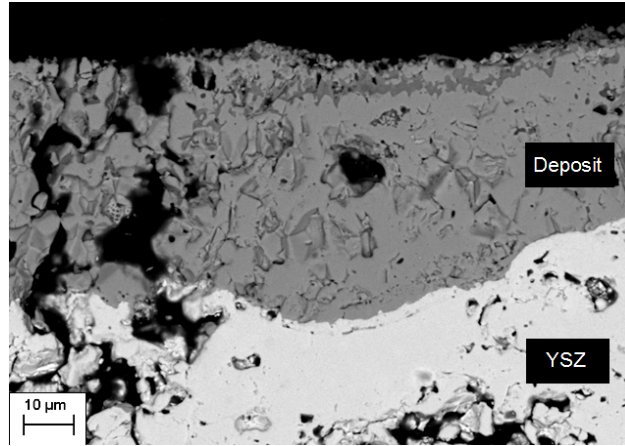
Figure 13 and Figure 14 show the cross-section SEM images of dark colour deposits (black and dark brown). From these microstructures, the dark colour deposits are clearly more consolidated than those light colour deposits. The denser deposit layer reveals less porosity which suggests a sintering effect may have taken place at these sites. Multiple phases are also identified from these SEM images. Recall from the surface EDS mapping of flagstone-like plates, calcium and aluminium signals were also identified. Signals of these elements came from the calcium and aluminium containing layer right under the flagstone-like plate surface; however, this denser phase is only a thin layer ( $\sim 5 \mu\text{m}$ ) and is not representative of the bulk of the deposit.

Figure 13 Cross-sectional SEM of black deposit revealing a dense layer near the surface

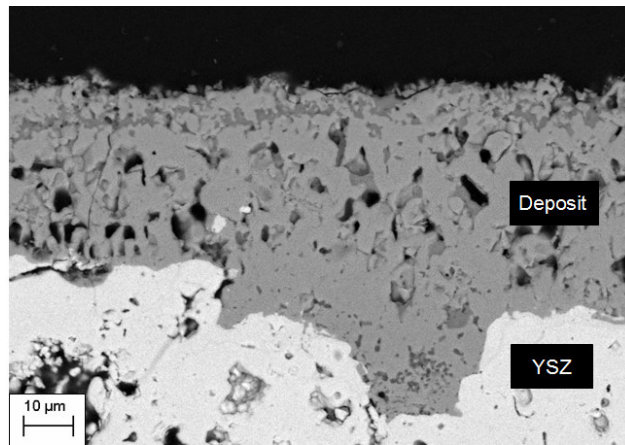
Figure 14 Cross-sectional SEM of dark brown deposit revealing a dense layer near the surface

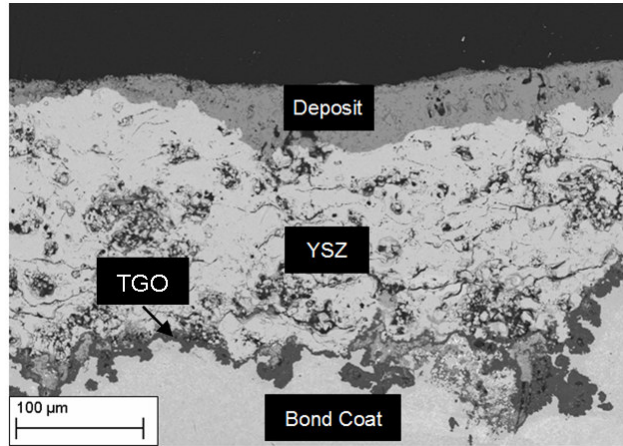
Growth of the thermally grown oxide (TGO) can also be measured from the cross-sectional SEM images. The thickness of the TGO layer under the black deposit surface (Figure 15) is considerably thicker than that of light brown deposit site (Figure 16). The growth rate of the TGO between a TBC and a MCrAlY bond coat is dependent upon temperature [4, 5]. Formation of TGO therefore provides evidence about the relative temperature experienced at these two sites. *i.e.* these data imply that the black deposit covered area had experienced a relatively higher temperature than the region with light brown deposit. Further analytical work will be performed to quantify this.

Figure 15 Cross-section SEM image of black deposit

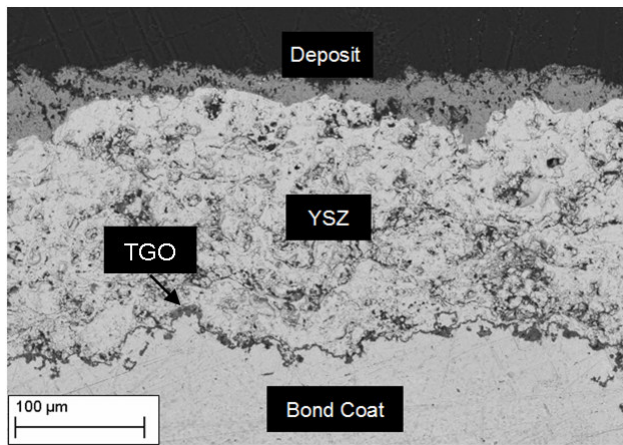
Figure 16 Cross-section SEM image of light brown deposit covered TBC

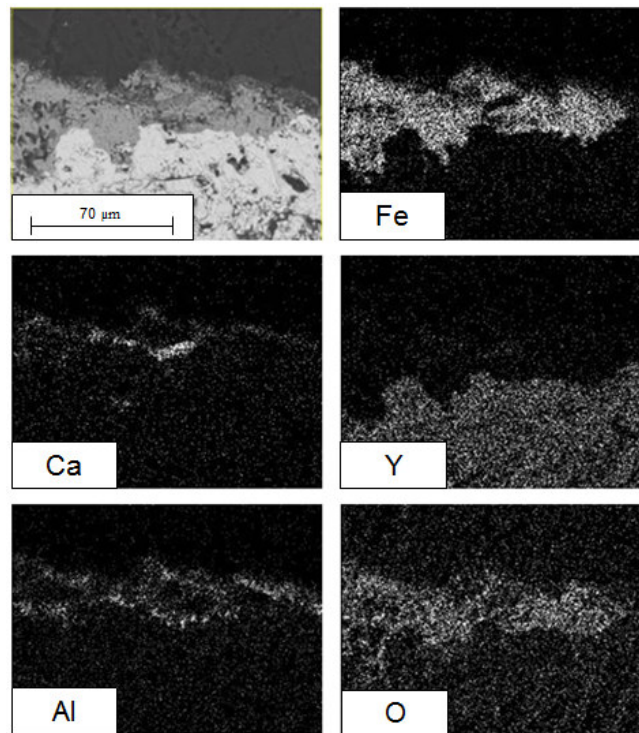
Cross-sectional EDS analysis examined the chemical composition and distribution of the contamination deposit. EDS mapping again reveals heavy iron content (~30 at%) with minor trace of calcium (~2 at%) and aluminium (~5 at%). Figure 17 shows the EDS mapping of a light brown deposit site. Calcium and aluminium were observed near the surface and the deposit / YSZ interface, whereas the bulk of the deposit is primarily iron oxides. The calcium and aluminium appear to be inhomogeneous, suggesting the existence of two different compounds. As comparison, EDS mapping of dark brown deposit is shown in Figure 42. Minor calcium and aluminium signals were again detected from these dense regions. In the study of other environmental degradation, yttria extraction was reported. Stott et al have shown that in the case of CMAS attack, yttria content could be extracted from the YSZ top coat [6, 7, 8]. However, as for this particular

iron oxide deposits, EDS mappings reveals no sign of yttria extraction (at least within the sensitivity of this measurement).

Figure 17 EDS mapping on the cross-section of light brown colour deposit site

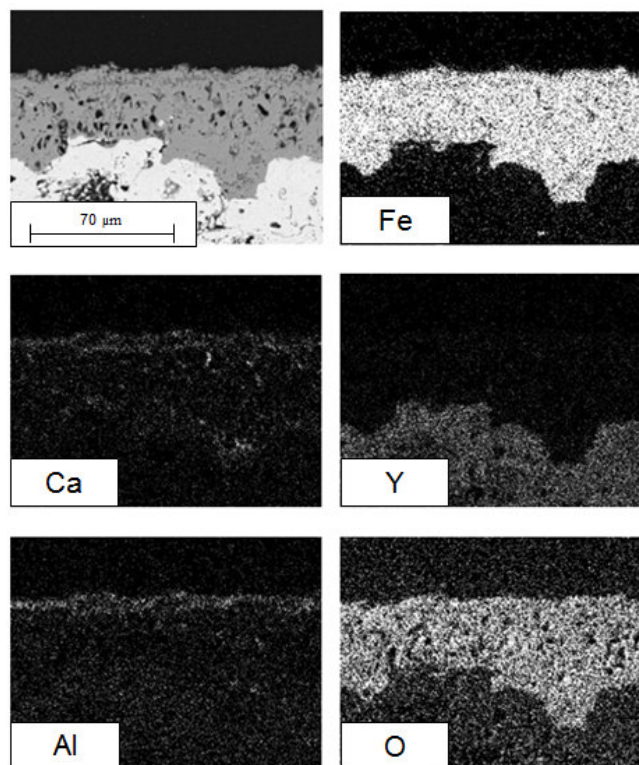
Figure 18 EDS mapping on the cross-section of dark brown colour deposit site

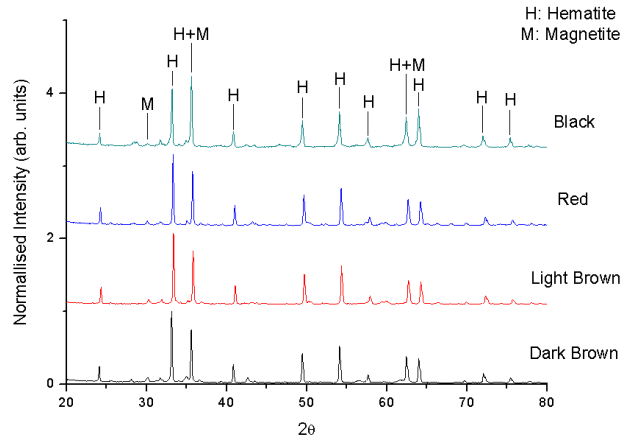
From the EDS analyses, various elements have been confirmed. It is our interest to know the correct phases of the primary contaminant present in this system, iron. XRD has been conducted at four different positions on the pressure side vane surface, covering both light and dark coloured deposits. Figure 19 shows the XRD spectra of black, red, light brown, and dark brown colour deposit surfaces. Since the deposits layers are generally thick (greater than 30  $\mu\text{m}$  in most surfaces) the XRD could only reveal the elemental phases near the surface. A mixture of hematite ( $\text{Fe}_2\text{O}_3$ ) and magnetite ( $\text{Fe}_3\text{O}_4$ ) phases have been identified.

Figure 19 XRD traces of black, red, light brown, dark brown colour deposit surfaces
