# AgCl-induced hot salt stress corrosion cracking in a titanium alloy

The mechanism of AgCl-induced stress corrosion cracking of Ti-6246 was examined at 500 MPa and 380 °C for 24 h exposures. SEM and STEM-EDX examination of a FIB-sectioned blister and crack showed that metallic Ag was formed and migrated along the crack. TEM analysis also revealed the presence of SnO<sub>2</sub> and Al<sub>2</sub>O<sub>3</sub> corrosion products mixed into TiO<sub>2</sub>. The fracture surface has a transgranular nature with a brittle appearance in the primary  $\alpha$  phase. Long, straight and non-interacting dislocations were observed in a brittle appearance fractured primary  $\alpha$  grain, with basal and pyramidal traces. This is consistent with a dislocation emission view of the the cracking mechanism.

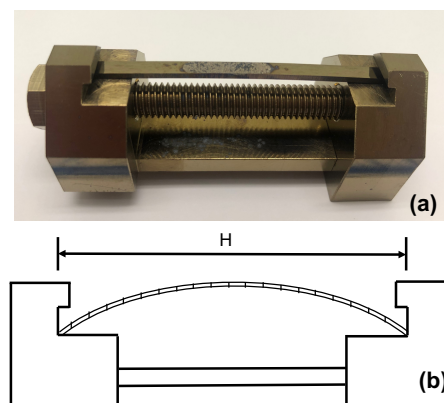
Figure 1: (a) Two-point bend rig used in this work; (b) schematic diagram of the sample and bend rig configuration.

Ti-6246 in a service-representative condition was provided by Rolls-Royce plc. 60 mm × 1.5 mm × 3.5 mm strip specimens for bend testing were obtained by electrical discharge machining (EDM) and then polished using an OPS colloidal silica solution (1:4). A two-point bending rig was used to apply uniform load across the strip surface, as illustrated in Figure 1. The rig is manufactured from titanium alloys to avoid effects of differential thermal expansion at elevated temperatures on the applied load. 3 mg AgCl powder (max. particle size 150 µm) was placed on the centre of the strip. A drop of distilled water was added to disperse the AgCl particles before evaporation. Two-point bending tests were then conducted at 380 °C and 500 MPa for 24 h in an air-circulating laboratory oven. These are the same conditions as in our previous work, where we examined the sample surface [19]. The applied stress  $\sigma$  was calculated according to ASTM-G41[20], as described in following equation

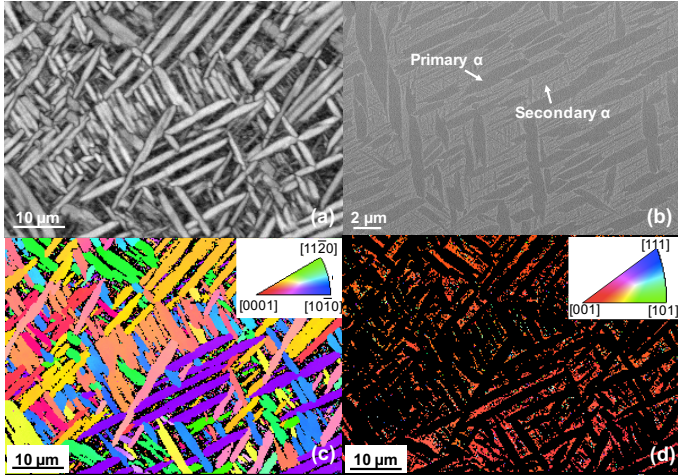
Figure 2: Micrographs showing the microstructure of as-received Ti-6246. (a) band contrast image formed from EBSD; (b) backscattered electron image demonstrating primary  $\alpha$  laths and fine secondary  $\alpha$  precipitates embedded in transformed  $\beta$  phase; inverse pole figure (IPF) maps of the (c)  $\alpha$  and (d)  $\beta$  phases, coloured according to the loading direction (hoop direction in the parent disc forging).

backscatter diffraction (EBSD) in a Zeiss Sigma 300 field emission gun scanning electron microscope (FEG-SEM) with an accelerating voltage of 20 kV and a working distance of 15 mm, as shown in Figure 2. The specimen surface after corrosion tests was characterised by optical microscopy and with a Zeiss Auriga FEG-SEM under an accelerating voltage of 5 kV. The cross section underneath the corrosion products was revealed by focused-ion beam (FIB) milling with a Ga<sup>+</sup> source at 30 kV and the chemical composition was analysed by energy dispersive X-ray spectroscopy (EDX) equipped in the same SEM. The accelerating voltage was 10 kV and the aperture size was 60 µm for this analysis. A cracked sample was characterised by transmission electron microscopy (TEM) and scanning TEM (STEM) in a JEOL-2100F at 200 kV. A TEM foil containing a crack was lifted out from the top surface with a dual beam FEI Helios Nanolab 600. A platinum protective layer was deposited on the surface to minimise damage from ion milling. The foil was made electron transparent with a thickness around 150 nm. Chemical analysis was then carried out using STEM-EDX with a 1 nm spot size. X-ray diffraction (XRD) was also conducted on the sample top surface to investigate the phases formed after corrosion testing, using a Cu K $\alpha$  1.54 Å source with step size 0.03°/s.

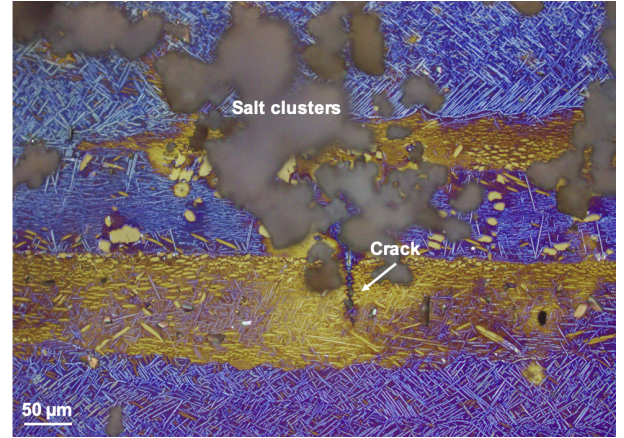
Figure 3: Optical micrograph of the top surface of sample tested under 500 MPa/380 °C after isothermal heat exposure for 24 h (image from our previous paper [19], taken in normal light. A small crack observed is highlighted with a white arrow, as are the AgCl particle clusters on the surface.

The macroscopic appearance of the sample surface after exposure to AgCl stress corrosion testing at 380 °C under a stress of 500 MPa for 24 h is shown in Figure 3. It can be observed that an uneven colouration appeared on the surface, corresponding to light interference with the oxide film formed during testing. Thus the colour relates to the oxide thickness [21, 22], which is dependent on the  $\alpha$  orientation and local oxidation/corrosion conditions. Such heat tinting is often used in weld qualification, anodization or as a diagnostic tool for thermal exposures. A straw-yellow colouration was observed in regions far from AgCl salt exposure, often with thicker (blue) oxide scales closer to the salt exposure. The underlying microstructure also affected the colours observed,

highlighting different prior beta grains. A small crack was found, indicated by a white arrow in Figure 3, on top of which reaction products could be found.

In Figure 3, the prior  $\beta$  grains are visible through variations in colour, most likely reflecting the oxide film thickness on the primary  $\alpha$  laths and their orientations. Turning to Figure 4, it appears that the primary  $\alpha$  laths are depressed relative to the transformed  $\beta$  regions, i.e. that the  $\alpha$  phase corrodes more. However, FIB sectioning (Figures 5 and 6) does not completely bear this out. From a fundamental perspective, the  $\alpha$  phase contains more Al, which easily forms volatile chlorides, but the  $\beta$  phase has far higher solubility for hydrogen.

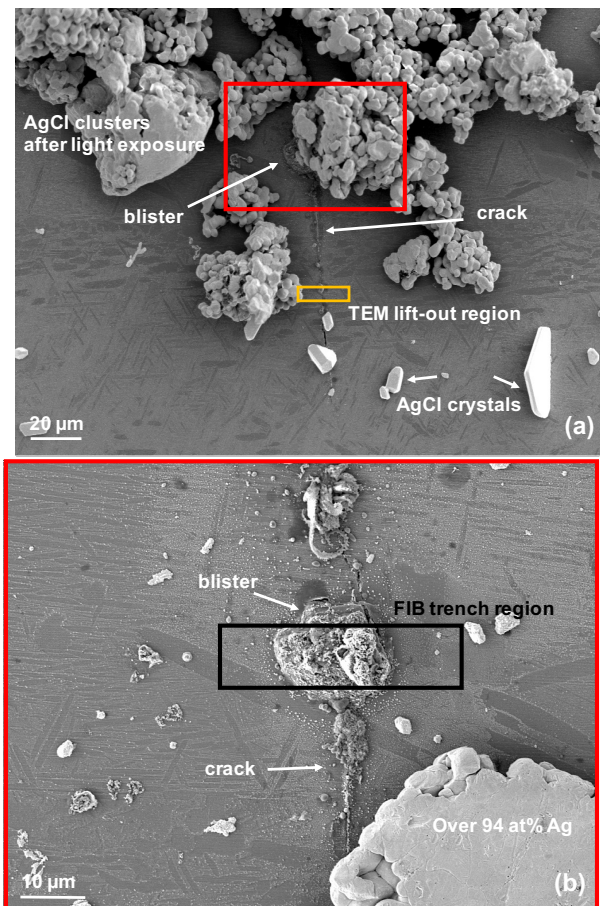
Figure 4: Secondary electron images of the tested sample surface after exposure at 500 MPa/380 °C for 24 h, showing a crack near salt clusters. (a) A blister formed underneath a salt cluster and (b) highlighted region from (a) exposed after removal of salt overburden by ultrasonic cleaning. The black box indicates the region protected by platinum coating prior to FIB milling to produce a trench for cross-sectional analysis. A TEM foil was lifted out away from the blister, as outlined by the orange box in (a).

The SEM image in Figure 4 illustrates a small surface crack adjacent to some clusters of AgCl. Unlike the granular and lenticular AgCl crystals as indicated by the bottom two white arrows in Figure 4(a), the salt clusters near the crack were composed of many nodular globular particles embedded in larger ones. EDX analysis on the area labeled in Figure 4(b) indicated the presence of more than 94 at% of Ag, which implied formation of metallic Ag on the applied AgCl. These features have been observed in previous work [23] and it is widely agreed that AgCl can photodecompose into metallic silver and chlorine under UV radiation, causing surface or volume darkening of AgCl [24, 25], as follows

Blisters and globular corrosion products were then exposed above the crack after removal of large clusters by ultrasonic cleaning in a dry beaker without any solvents, as shown in Figure 4(b). A region of a blister was protected by platinum coating then focused-ion beam (FIB) milled, as indicated by the black

A TEM foil was lifted out from the top surface of the sample from the location highlighted in Figure 4(a) after a test where a crack propagated through the surface, which was covered by small blister-like corrosion deposits. STEM bright-field (BF) imaging of the foil, Figure 6(a) revealed that the crack penetrated into the underlying alloy. The crack path propagated

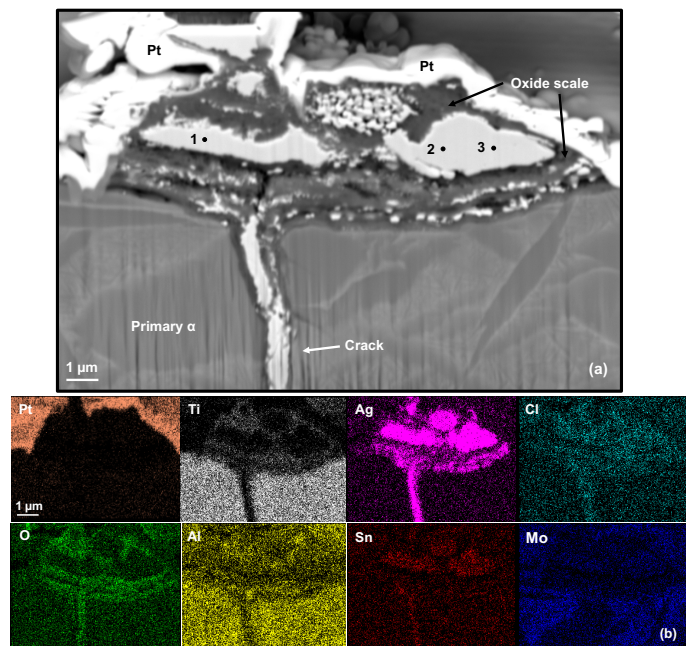
Figure 5: (a) Backscattered electron image revealing the underlying layered structure inside the blister (Figure 4b) after FIB milling; (b) SEM-EDX elemental maps of the red highlighted region

rectangular box, to reveal the cross section and conduct chemical analysis shown in Figure 5(a). It can be seen that layered and porous corrosion products were generated inside the blister. They were found to accumulate into a shallow pit, also filling the crack propagating below. This crack began by propagating through a primary  $\alpha$  grain exposed at the surface.

EDX point analysis in Table 1 suggested that the bright Ag-rich layers with different morphology were surrounded by (grey) oxide scales enriched in Ti, Al and O, e.g. consisting of titanium and/or aluminium oxides. This implies that Ti and Al were likely active and diffused outward during the corrosion reactions. The top layer of oxides showed a heterogeneous appearance with inclusion of Ag-rich particles, moving inward through the blister. The top oxide/Ag adherence was intimate whereas oxide spallation was observed deeper in the blister, but above the base alloy. Cellular and globular Ag-rich structures were generated on the top, surrounded by a dense oxide layer around 1  $\mu\text{m}$  in thickness within the blister. Aggregation and coalescence of Ag-rich particles were also observed at the bottom of the pit. It has been suggested that local chemical potential might control the Ag formation morphology, which was closely linked to reaction kinetics. It is also well known that Ag prefers island growth [26] (The mechanism of Ag/oxide alternation is unknown).

Excess corrosion products are found to deposit into a shallow pit-like region, as observed in Figure 5(a). The brittle oxide is found to crack under the tensile stress, while the ductile Ag-rich layers above it remain continuous, which may slow down the evaporation of HCl or  $\text{Cl}_2$ . Since the ratio between penetration and the lateral corrosion depth is less than 1, pit formation is not considered in this case [45]. Crack initiation is thought to be due to the slip-dissolution process under tensile stress. It is proposed [8] that slip promoted by hydrogen adsorption into the metal can expose material on the slip line to the corrosive environment, resulting in localized anodic dissolution. A corrosion tunnel can then be formed, which can then act as the crack initiation site. The fractographic appearance is one of microstructure-sensitive cracking, implying a role for the morphological and/or crystallographic orientations of the underlying  $\alpha$  and  $\beta$  phases.

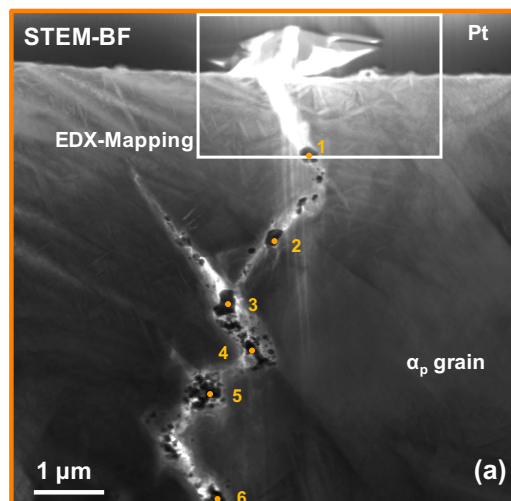
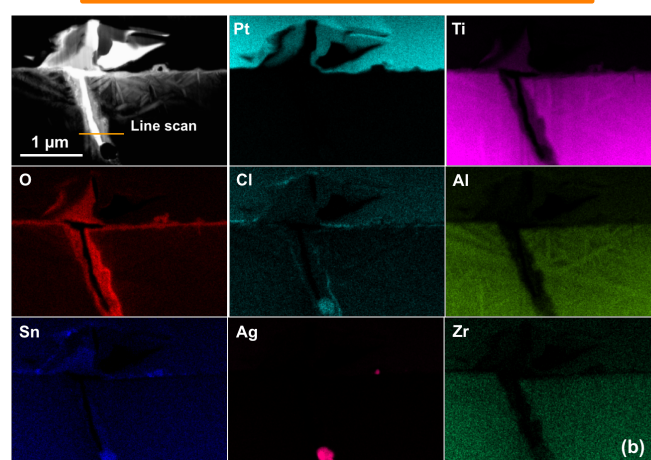
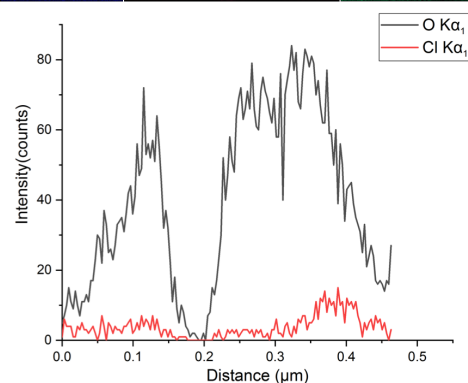
Figure 6: (a) Bright-field STEM image (spot size=1nm) of the TEM foil lifted out from the crack in Figure 4(a), showing a transgranular crack propagation path; (b) STEM-EDX elemental maps of the region highlighted in (a), and (c) STEM-EDX line scan analysis showing intensity variations of O and Cl along the line identified in (b). Elevated levels of Cl are present at the metal/oxide interface.

through the  $\alpha$  laths, with branching in between, with the crack itself observed to be partially filled with heterogeneous corrosion products. Cracking at the interface between the primary  $\alpha$  and the transformed  $\beta$ , e.g. due to hydride formation at the interface, was not observed.

Regions of bright contrast in Figure 6(a) but with no corresponding intensity in the STEM-EDX maps, Figure 6(b) are inferred to be empty regions of the crack. Regions of the crack of low intensity (black) in the BF image were found to be associated with high contents of Ag. The crack wall itself was found to be elevated in O content.

Table 2: STEM-EDX point analyses (at.%) at the points denoted in the Ag-rich layer within the crack in Figure 6 (Cu removed, e.g. from the sample holder).

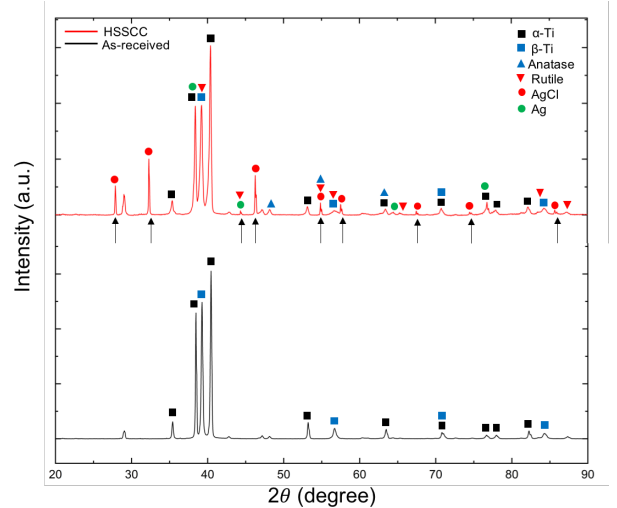
Figure 8: X-ray diffraction pattern obtained (Cu K<sub>α</sub> radiation) from the as-polished sample surface and after stress corrosion cracking testing.

To complement the EDX results, bulk powder X-ray diffraction was conducted on an as-corroded sample surface that had

been tested at 380 °C for 24 h, Figure 8. The primary  $\alpha$  and  $\beta$  phase peaks can be readily identified by comparison to an uncorroded sample. A number of very small peaks (e.g. at 29.0°, 42.9° and 47.2°) in the as-received sample correspond to background from the sample holder. In the corroded sample, additional peaks indicated by the black arrows were observed, which match well to AgCl. There are indications of the pres-

ence of Ag (e.g. the increase in intensity of the peaks at 77°), as distinct from TiO<sub>2</sub> (the peak at 44° which could be either Ag or TiO<sub>2</sub>). However, the TiO<sub>2</sub> films observed using electron microscopy were very thin, so it is perhaps unsurprising the TiO<sub>2</sub> is difficult to unambiguously observe. Therefore bulk X-ray diffraction analysis provided only limited additional information, so instead we turn to TEM-based diffraction phase analysis.

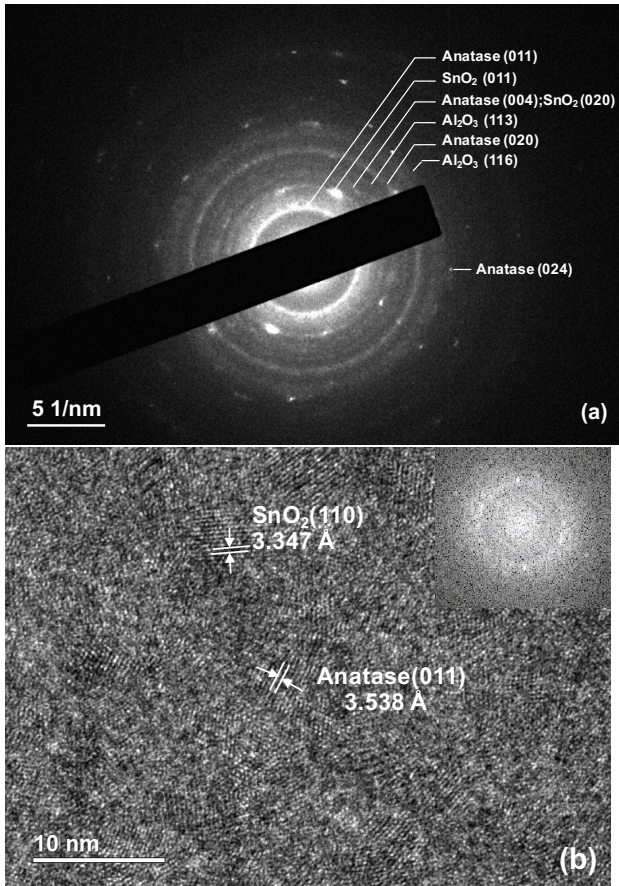
Figure 9: (a) Selected area diffraction (SAD) patterns and (b) high resolution TEM (HRTEM) image of the corrosion products formed above the crack mouth as illustrated in Figure 7(a).

patterns from this region were then matched with the crystal structures of TiO<sub>2</sub>, SnO<sub>2</sub> and Al<sub>2</sub>O<sub>3</sub>. In this case, anatase was determined as the form of TiO<sub>2</sub> occurring, which is thermodynamically unexpected [33, 34]. However, it has previously been suggested that the formation of nanocrystalline anatase particles can be favoured owing to its lower surface free energy and rapid crystallization [35, 36]. Besides, the d spacing measurement of the most intensive diffraction ring was 3.7 Å, slightly larger than d spacing of (011) planes for anatase. It was postulated that doping of other elements in anatase might expand the lattice structure [36].

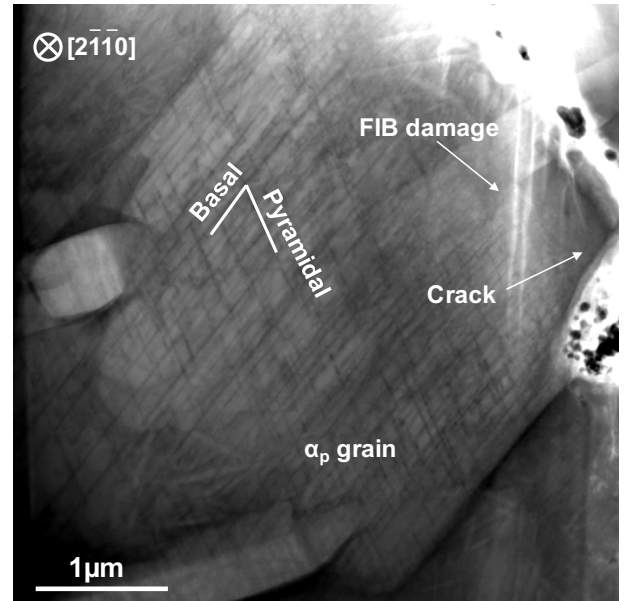
Figure 10: STEM-BF image showing high dislocation density in a primary alpha grain near the crack.

STEM-BF imaging, Figure 10, of the large primary α grain in Figure 6(a), was performed to highlight the dislocation structures associated with cracking. Long, straight dislocations of basal and pyramidal trace were observed.

density across the whole grain was not observed in previous study on NaCl HSSCC of Ti-6246, especially not adjacent to the fracture surface within 1  $\mu\text{m}$  distance [40]. Also, less dislocation entanglements were seen in this case, which could imply a change of the embrittlement mechanism ahead of crack tips for AgCl HSSCC.
